Rail Accident Report

Head-on collision between a passenger train and a freight train  
in Tempi, 28 February 2023

RL01-2025, 27 February 2025

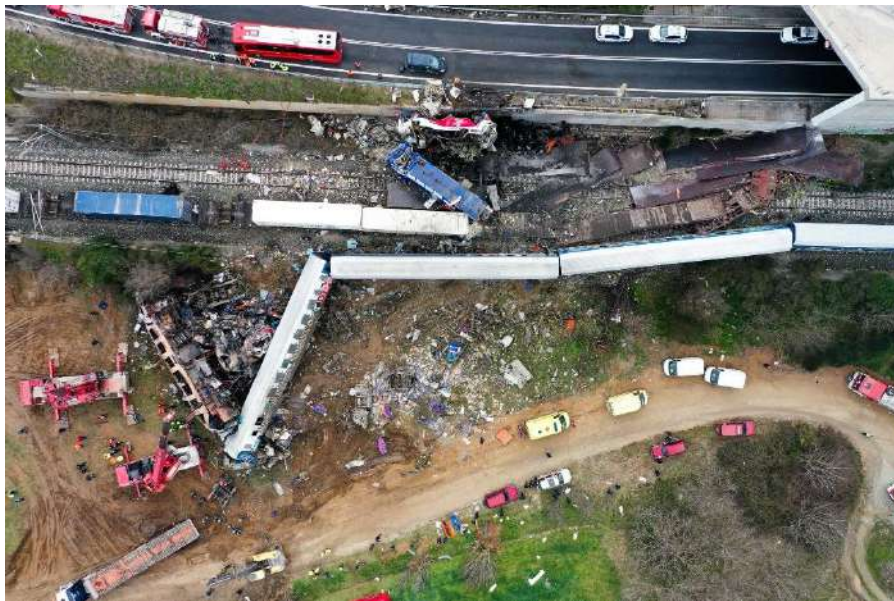
Figure 10. The end position of the 3 locomotives and some of the passengers coaches and freight wagons (<http://www.intime.gr/>).

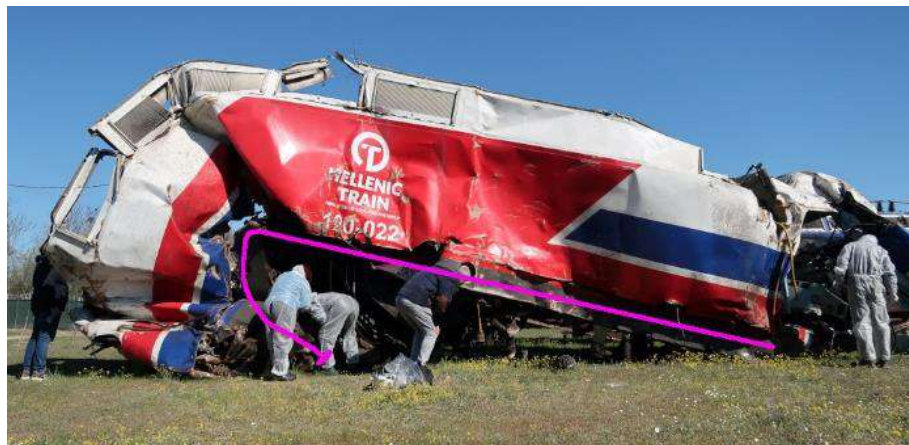
Figure 14. The first locomotive of the freight train (120-022) showing extreme damage from the very heavy head-on collision with the locomotive (120-023) of the passenger train.

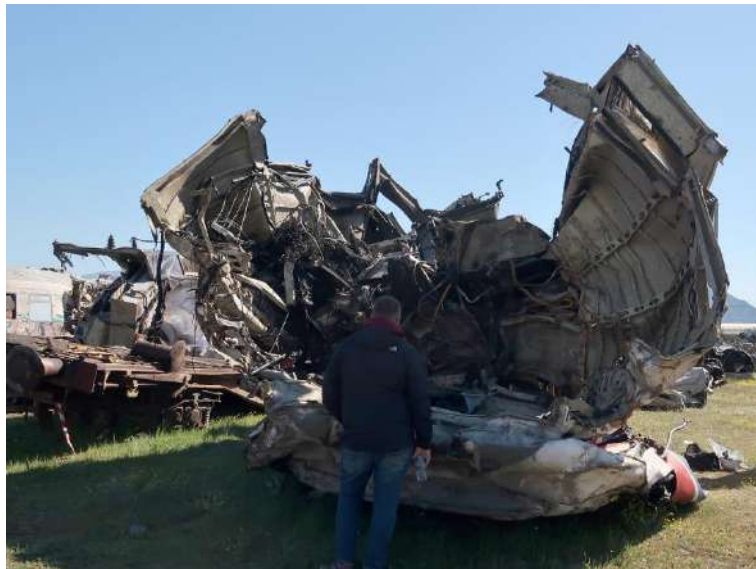
Figure 16. Front view of the locomotive 120-022, roof missing.

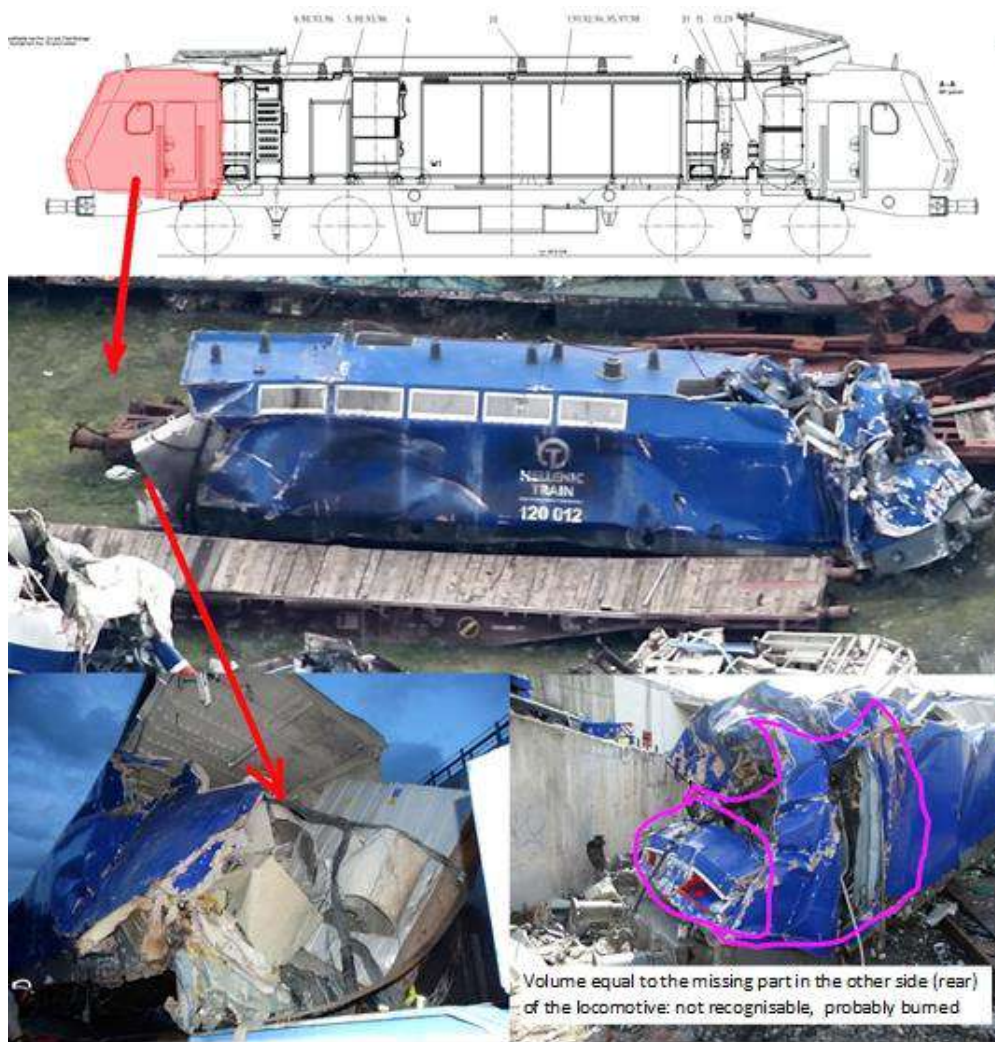
136 The rear driver's cabin of the 120-012 locomotive appears to be cut off from the rest of the vehicle and it cannot be completely identified anywhere among the debris, apart from a small part of its roof and top headlight (in front of the first container). The rest of the cabin cannot be identified as a whole and also the front panel with the painted number and the two red headlights are also not recognisable among the debris. Presumably, the missing structure is among the crashed and burned remains of the Restaurant Car, as this is the only place in the whole accident site where the fire burned so fiercely that it totally consumed the heavy industrial-grade paint of the blue locomotive, making it unidentifiable.

Figure 20. Missing rear-end of the locomotive 120-012.

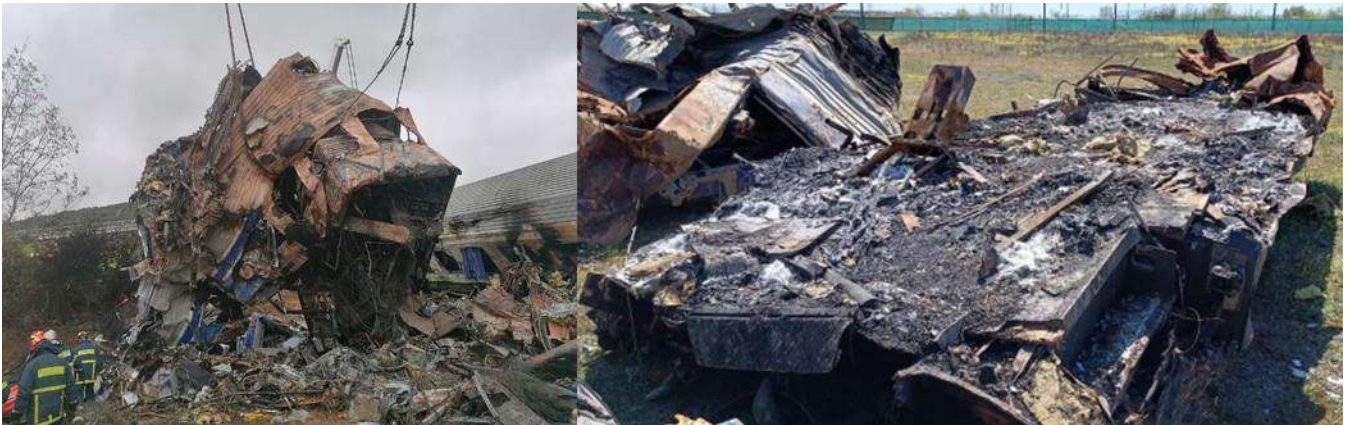
137 This second collision causes very heavy damage to the Restaurant Car (Figure 21) that is bent into an S-shape mostly due to this initial impact but also sustaining damage while rolling and hitting the ground on its way to the lower verge, to end almost on top of the remains of the locomotive 120-023 and the destroyed A1 first-class coach.

Figure 21. Remains of the Restaurant Car, on the left, S-shaped as found on-site, and on the right, its platform at Koulouri site.

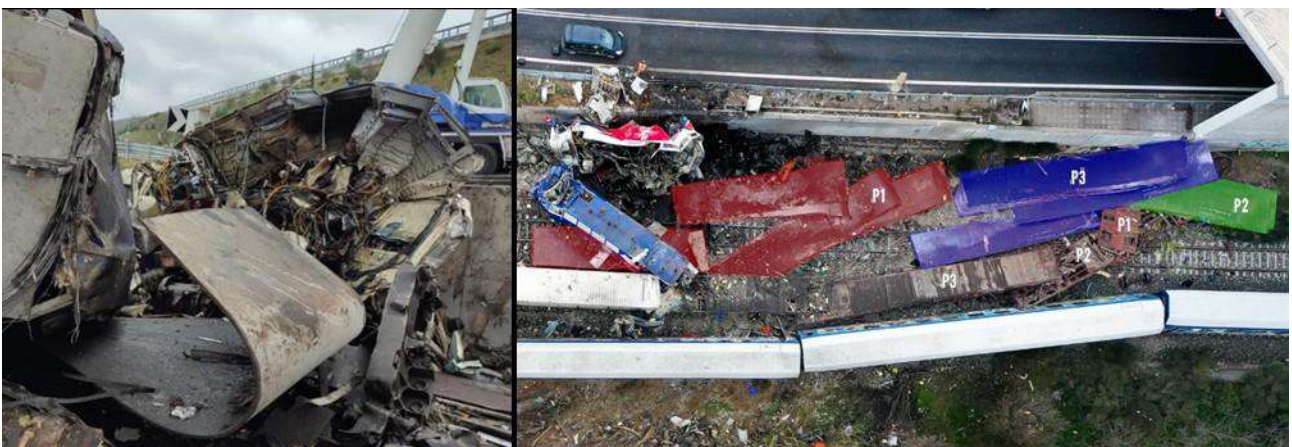
138 By comparing the damage to the steel plates and the Restaurant Car, it can be considered as most likely that the initial impact to the Restaurant Car came not on its front bumper but underneath its “belly”, indicating that the Restaurant Car had a slightly “nose-up” attitude at the moment of the impact, which is consistent with the damage observed on the first and presumably topmost steel plate that was found wedged underneath the blue 120-012 locomotive. Meanwhile, the 1st platform of the freight train sustains very heavy damage from the impact with the Restaurant Car that leaves it bent in half and wedged under the remaining steel plates against the wall, and spread few meters after the collision, in the area before the entrance of the tunnel. (Figure 13, Figure 22).

Figure 22. Remains of the top steel plates and final position of the 3 sets of steel plates.

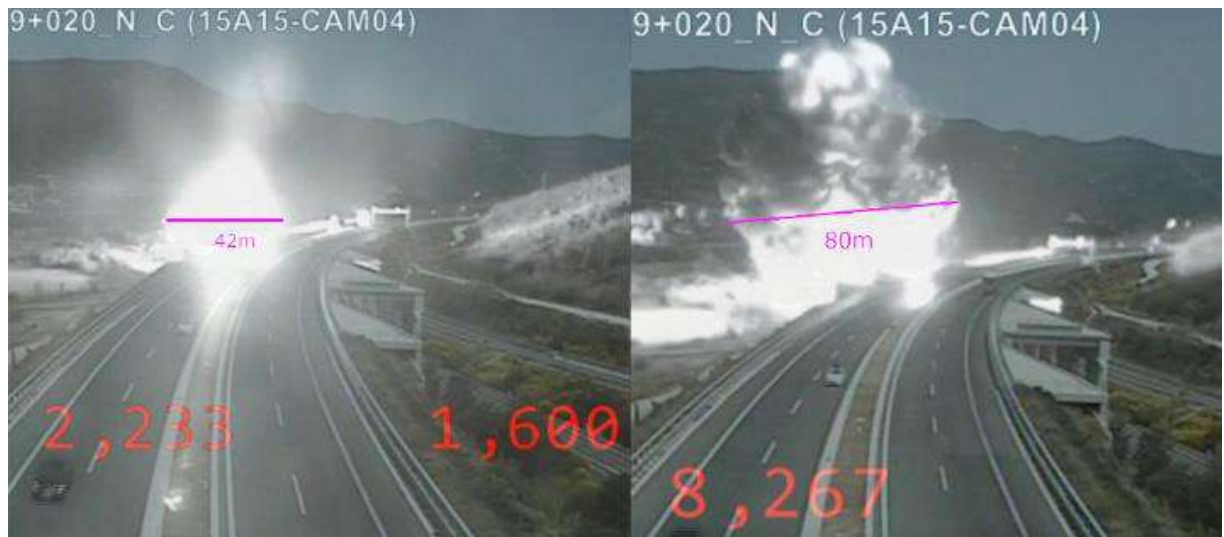
- 147 At the same time, the catenary lines themselves (both lines, one for each direction of travel) have been ripped off due to the collision, but the power was already cut within 0.2-0.3 seconds of the short circuit. Approximately 0.3 seconds after the end of the arc flashes, a fireball starts forming from the ground level and very rapidly expands upwards to a size of approximately 42 meters in diameter, which burns for approximately 2 seconds.
- 148 At approximately 2 seconds after the initial ignition, a second stage starts, when a new fire plume can be observed, moving northbound, away from the 1<sup>st</sup> stage fireball. This new fire plume is feeding the original fireball until it grows to almost double the size (80 meters) at approximately 4 seconds after ignition (Figure 28, Figure 29, Figure 30).

Figure 28. First (left) and second stage (right) of the fireball.

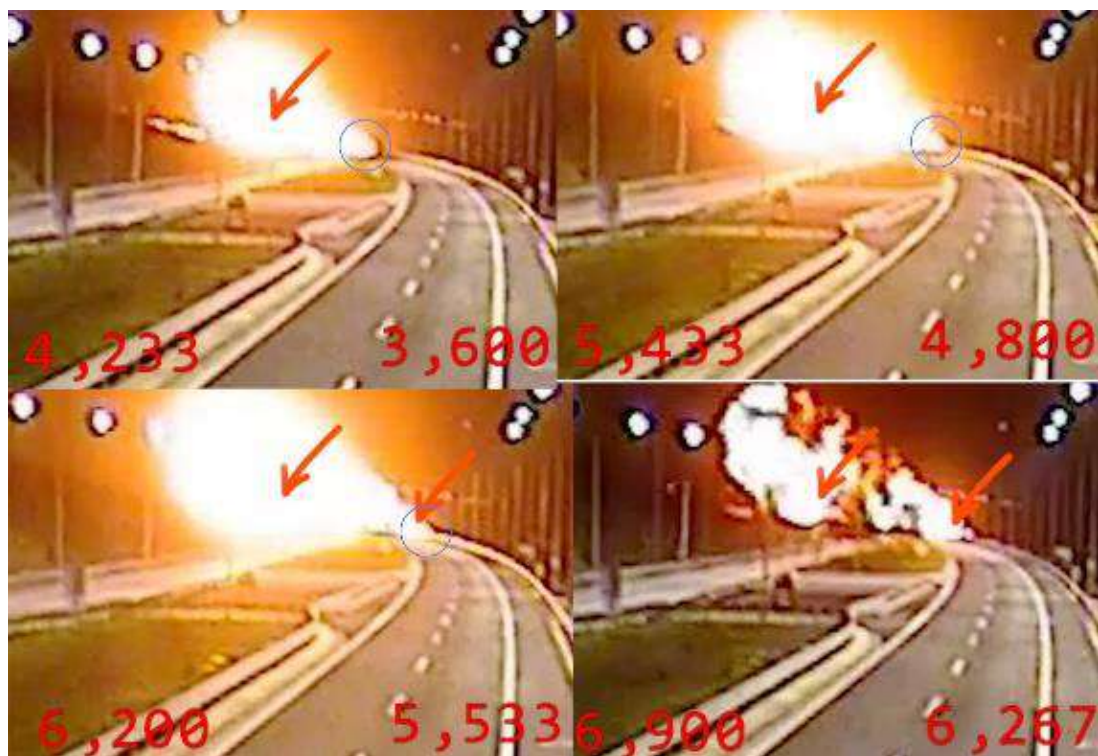
Figure 29. Second stage, fireball (left side of pictures) and fire plume (right side of the pictures)

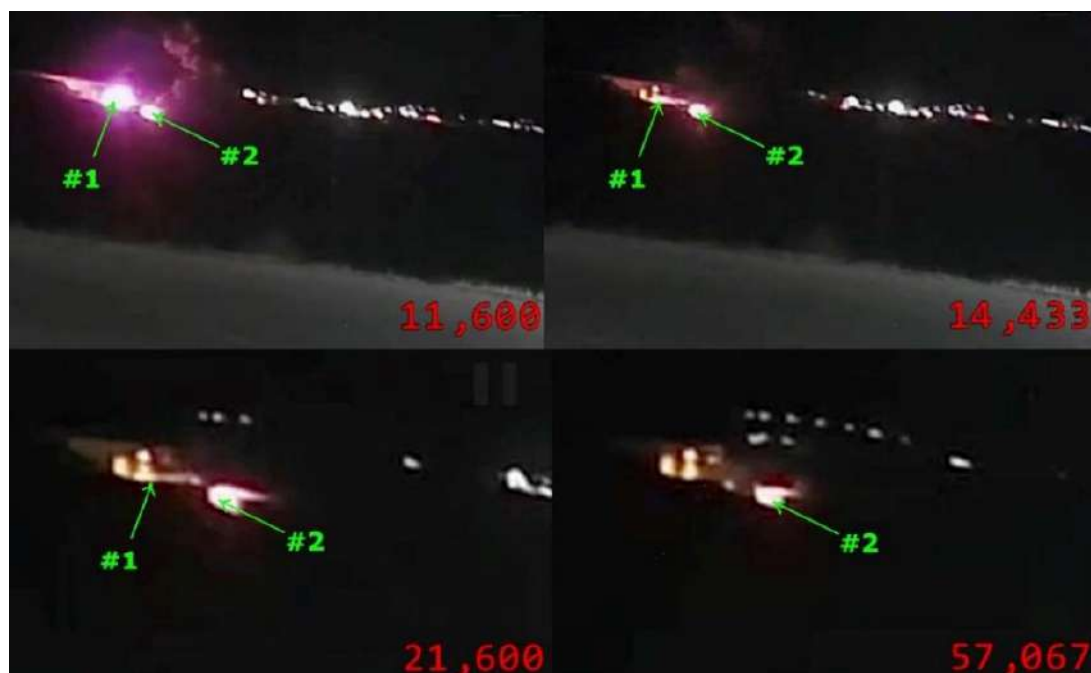
Figure 31. Pool fires #1 and #2

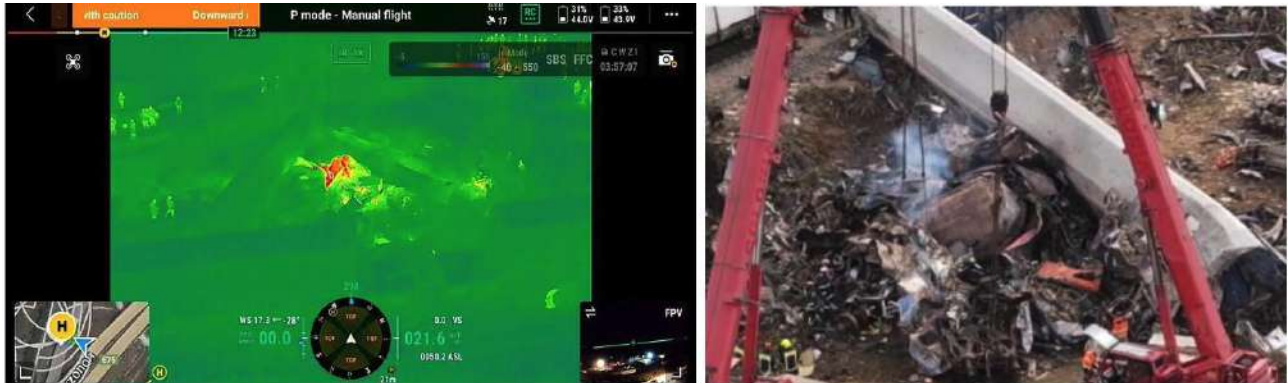
Figure 32. Fire simmering inside the Restaurant Car for 12 hours.

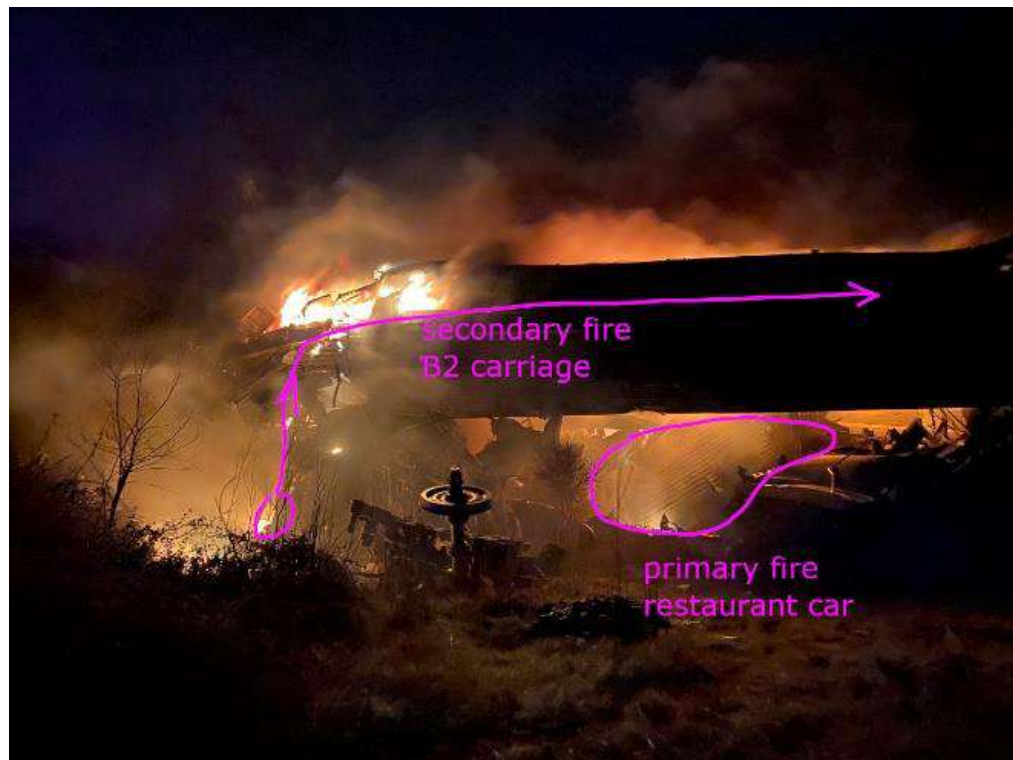
Figure 33. Another fire started at the front of the B2 coach.

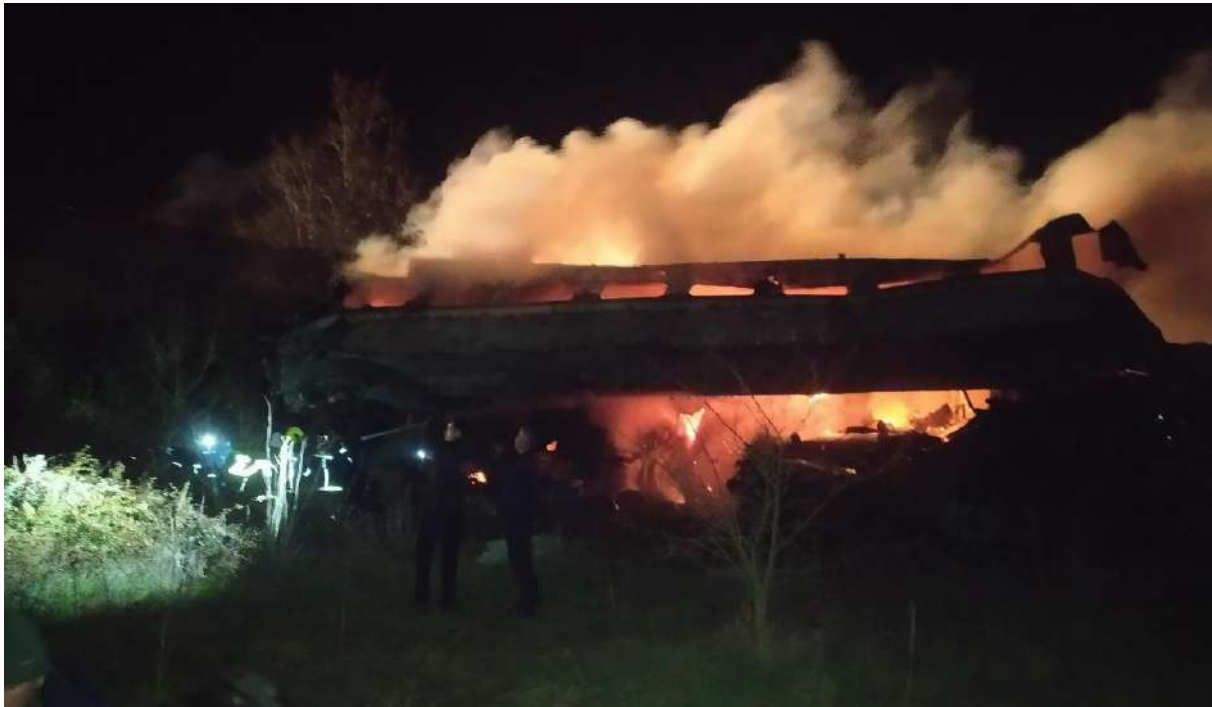
*Figure 34. Photo showing the heavy fires in the Restaurant Car area (behind), and on the B2 coach (front, above) (Source: EDAPO).*

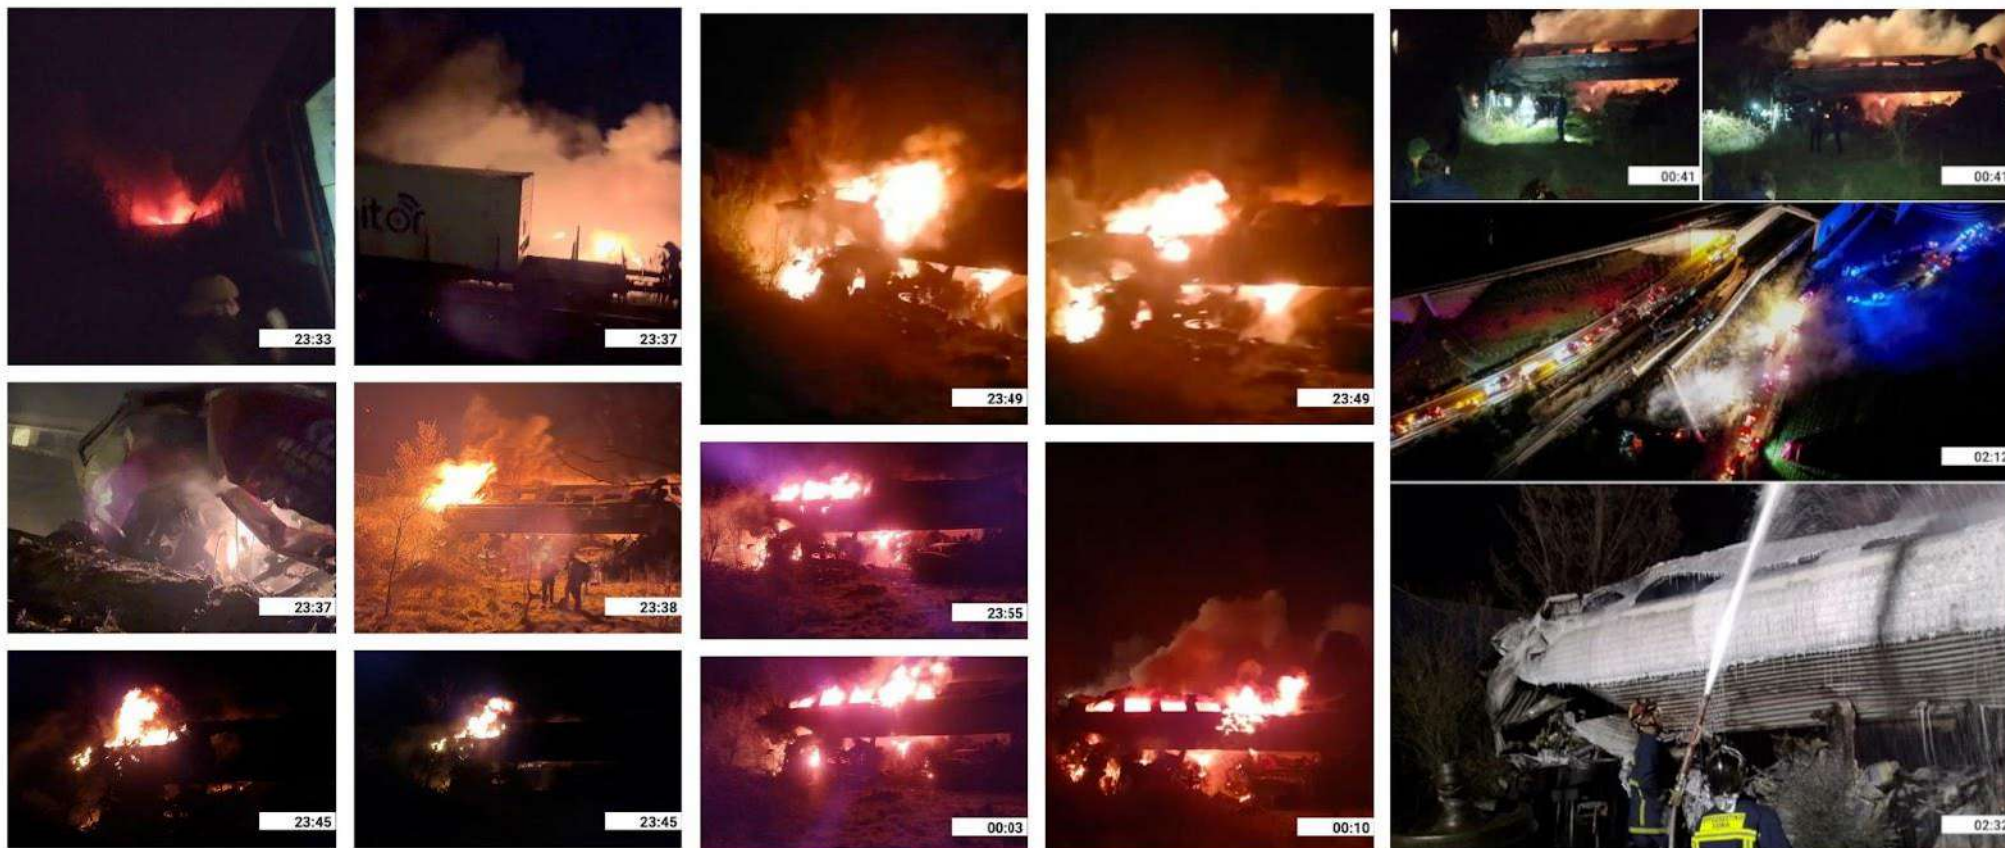
Figure 35. Photos of the fires development and their timestamp (source: EDAPO).

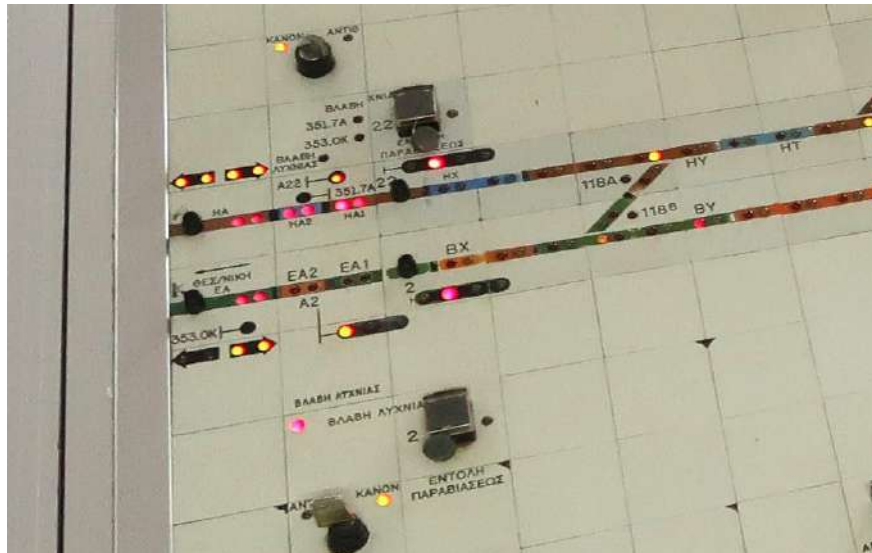
Figure 49. Section EA3 (indicated EA to the left of EA2 on the picture) of the control panel incorrectly indicating an occupation.

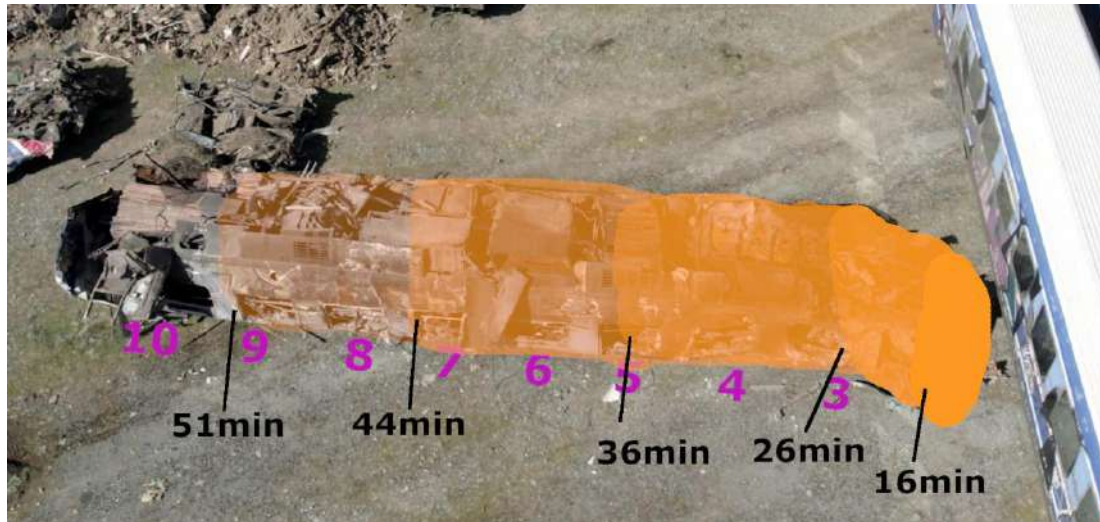
Figure 57. Progression of the fire in the B2 coach (from right to left, in minutes). (Source: EDAPO)

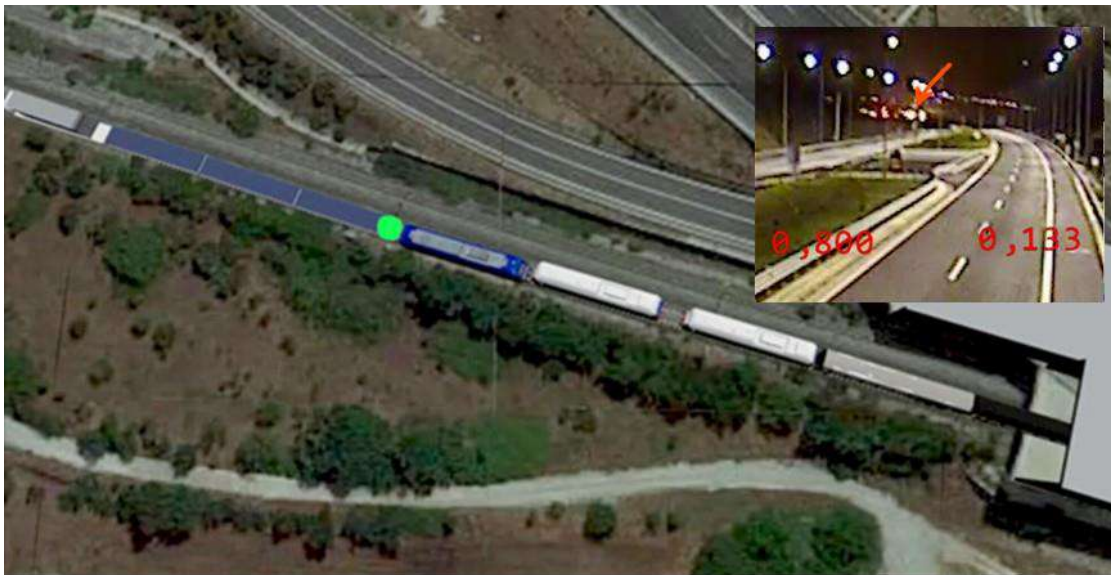
Figure 58. Estimated point of initial ignition.

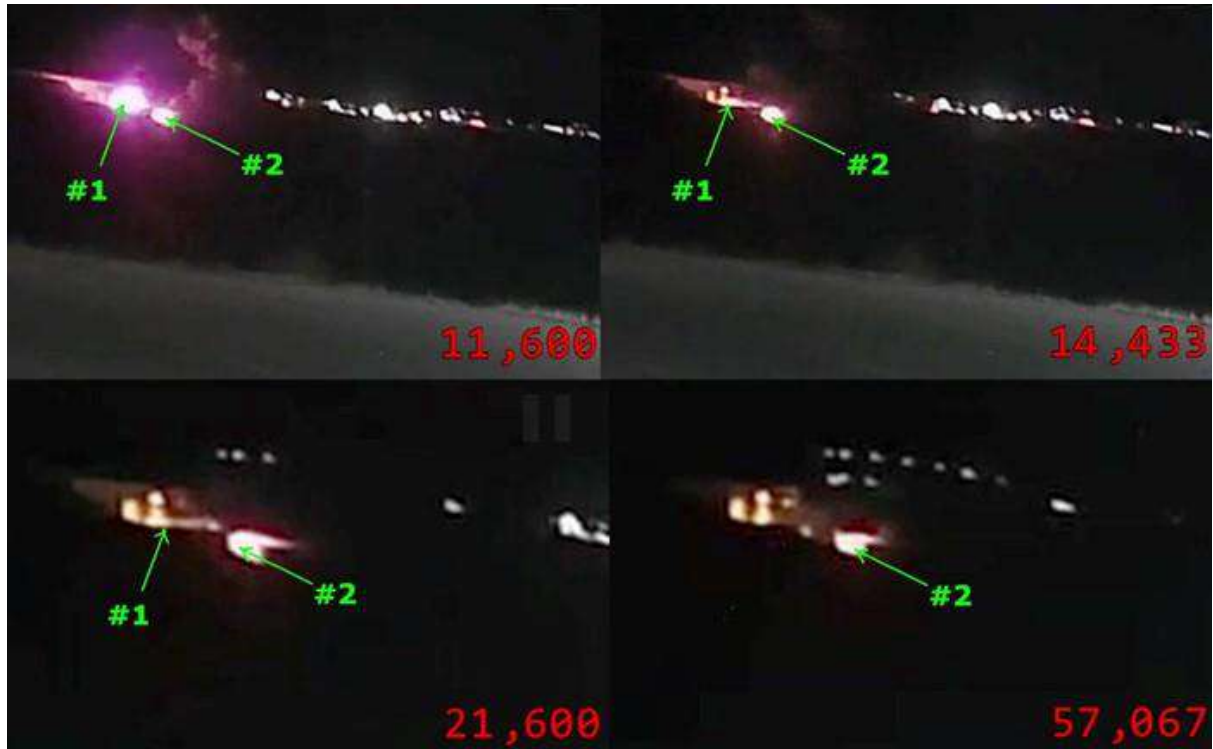
Figure 62. Fire plume moving into pool fire #2, as observed by the "Maliakos-Kleidi" camera.

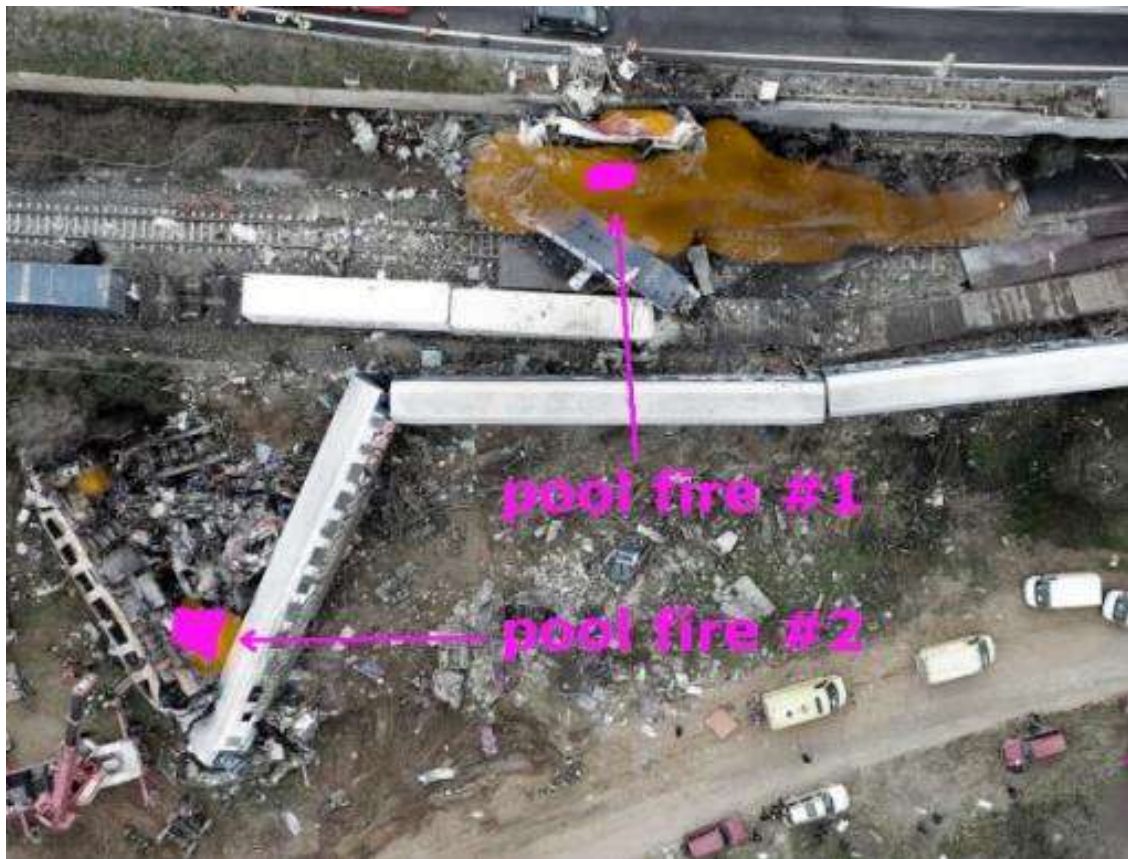
Figure 63. Location and approximate size of pool fires #1 and #2.

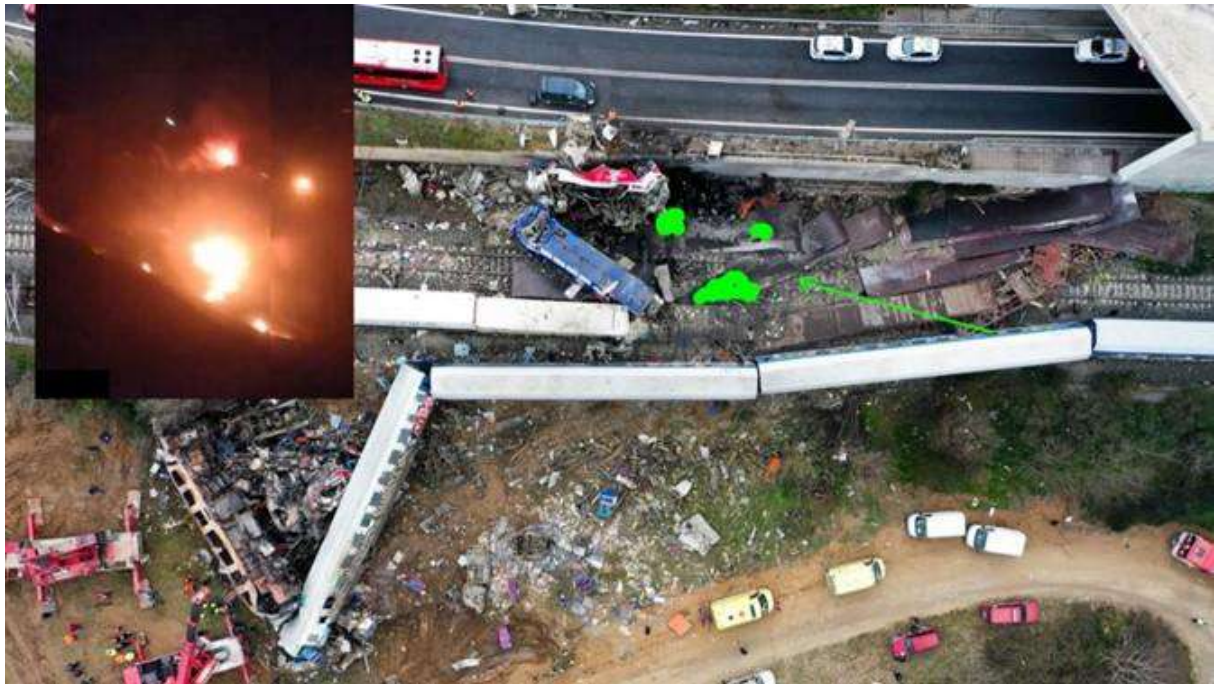
*Figure 64. Fire inside the transformer of freight train as a secondary result of pool fire #1.*

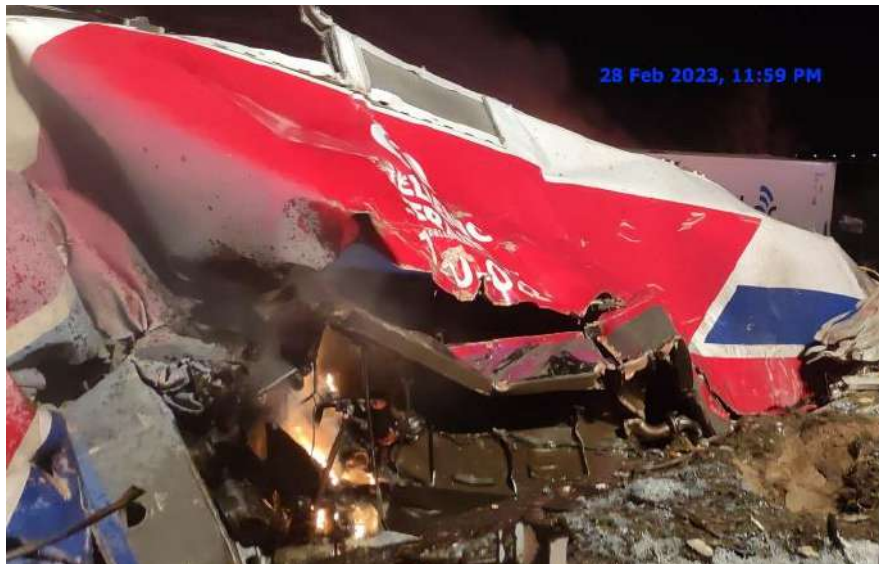
Figure 65. A local fire inside and outside the broken transformer of the first locomotive of the freight train, 40 minutes after the accident.

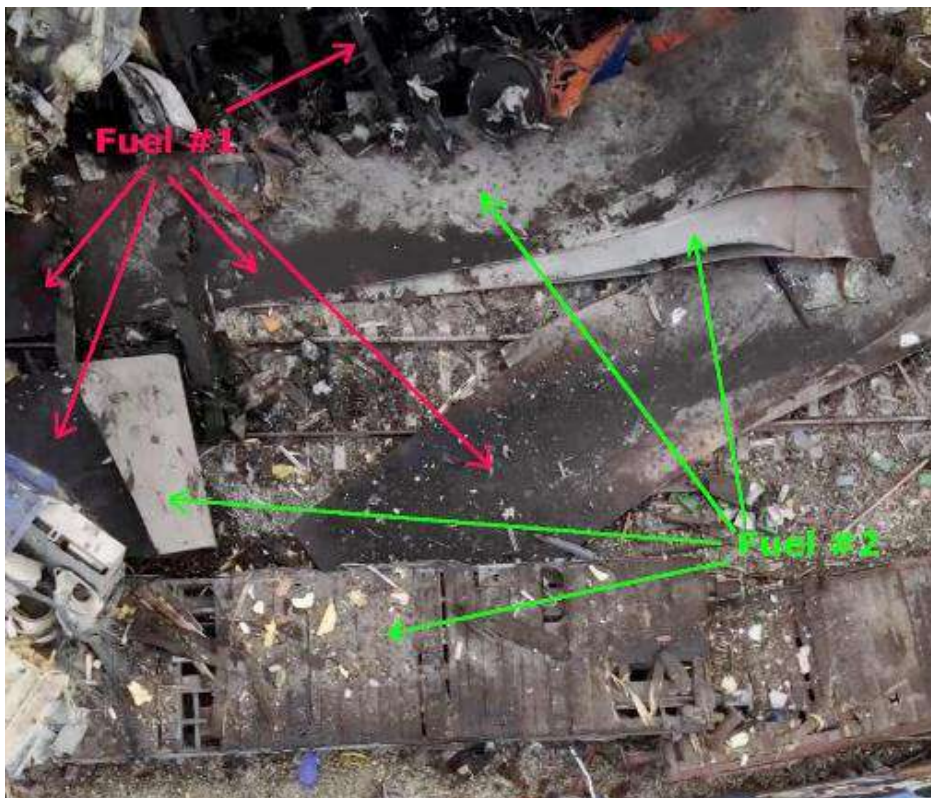
Figure 66. Evidence of two different fuels burning in the pool fire #1, one leaving black, the other leaving white residue.

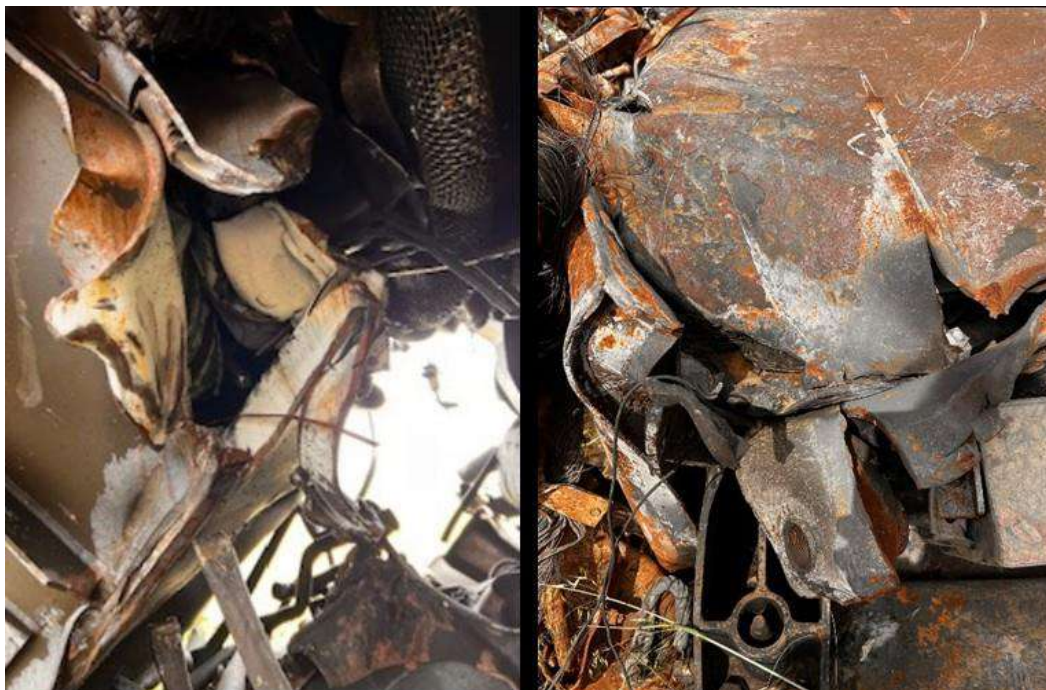
*Figure 67. Large cracks of the transformer still attached under the 120-022 locomotive (Left). Bumps, folds, rips and large cracks of remaining locomotive transformer 120-023 (right), see also Figure 61.*

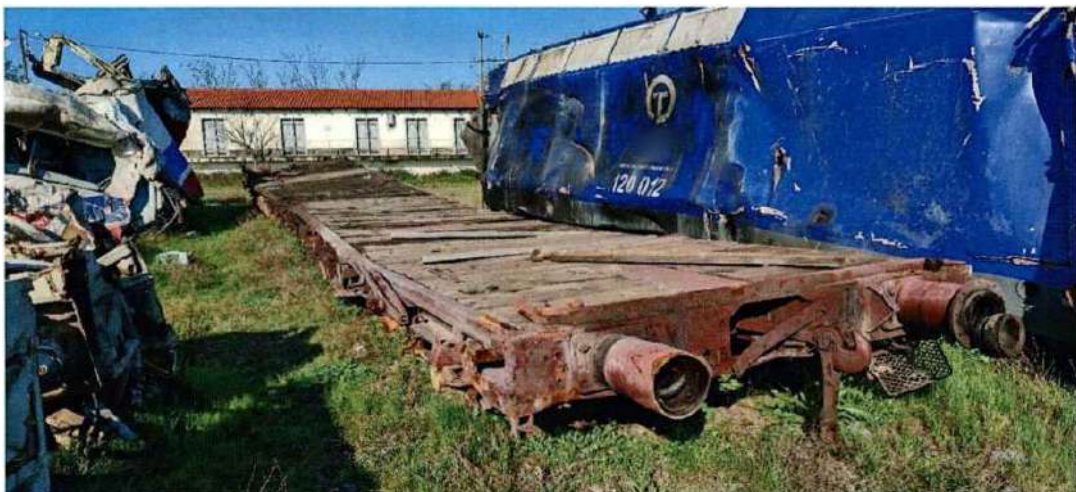
Figure 81. Position 5) nr 3 platform carrying steel plates, lost bogies from derailment, slight damage (twist) due to crash from the rear.

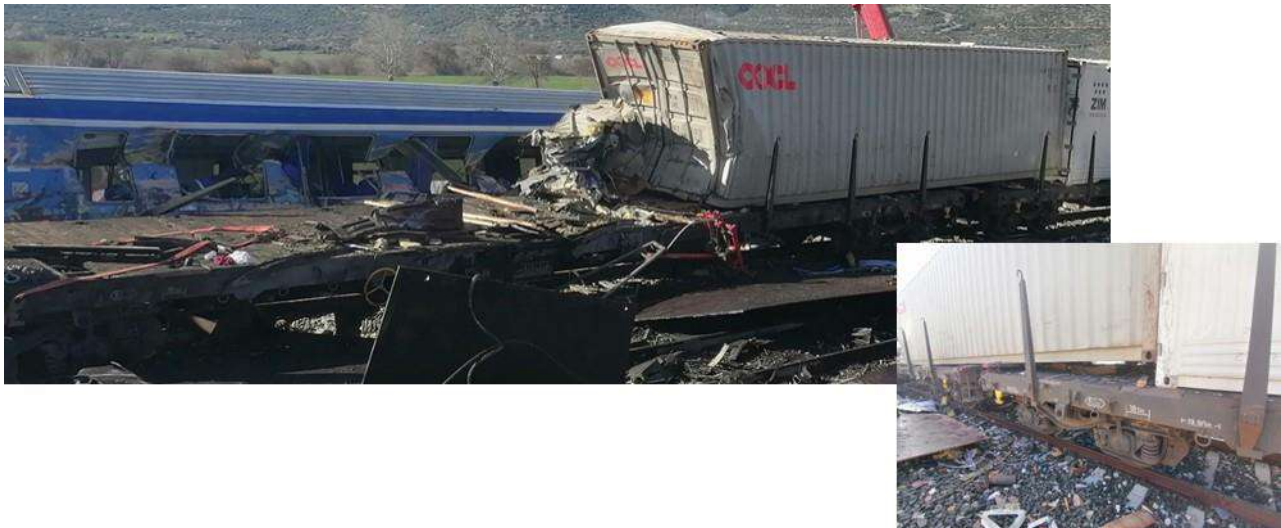
Figure 83. Positions 6) and 7) – on the left, the platform nr 4 (damaged, lost front bogie, not derailed) carrying the first container. On the right, the first container (OOCL) is shifted in rear direction, hurting the next container (ZIMonitor).

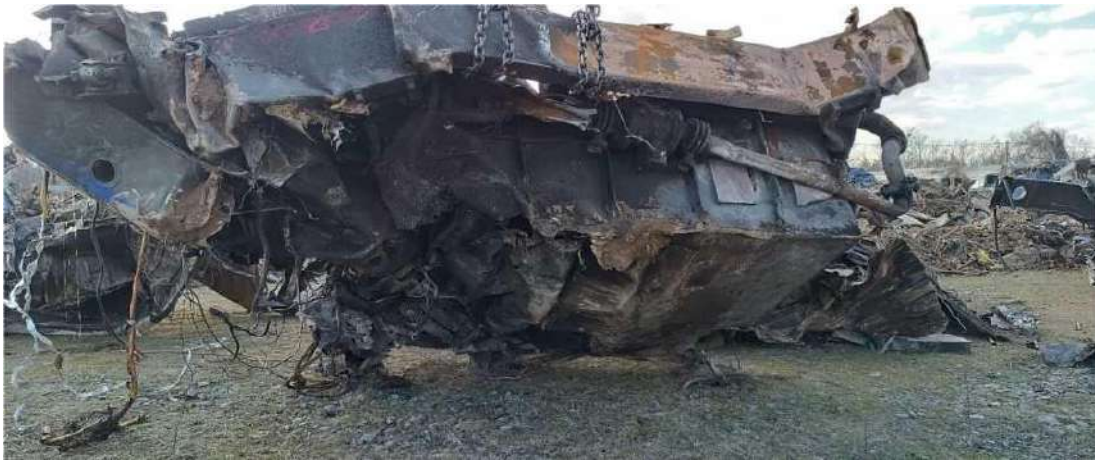
*Figure 85. Position 1) 120 023 locomotive, totally destroyed, broken into large pieces. Remaining piece of the basement platform. Part with transformer still visible. Other side in Figure 17. At the position 2) the A1 1st class coach, totally destroyed, has broken into small pieces, and was not recognisable as a whole vehicle.*

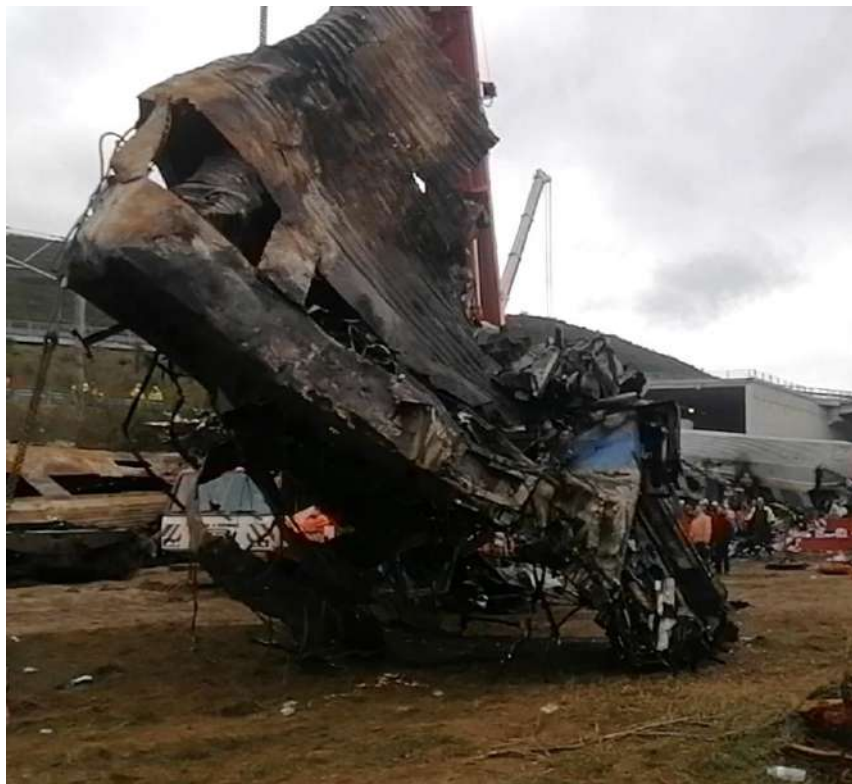
*Figure 86. Position 3) Restaurant Car, very heavily damaged from initial crash (folded, bent into S-shape) and burned down. Here, suspended from the crane cables.*

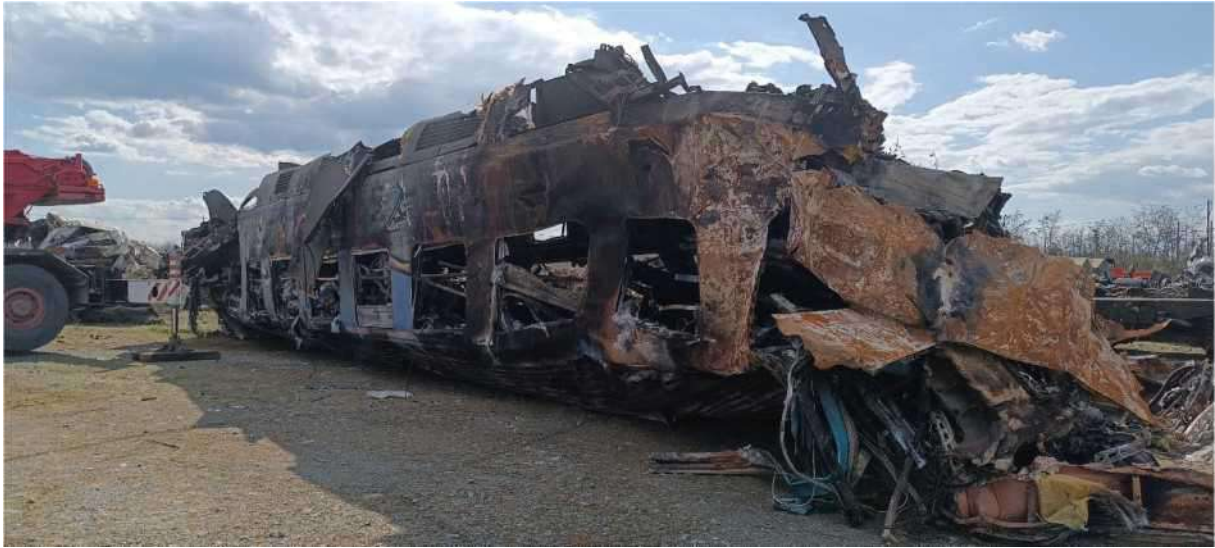
*Figure 87. Position 4) B2 2nd class coach, heavy impact damage in the front and rear, fire slowly consumed it.*

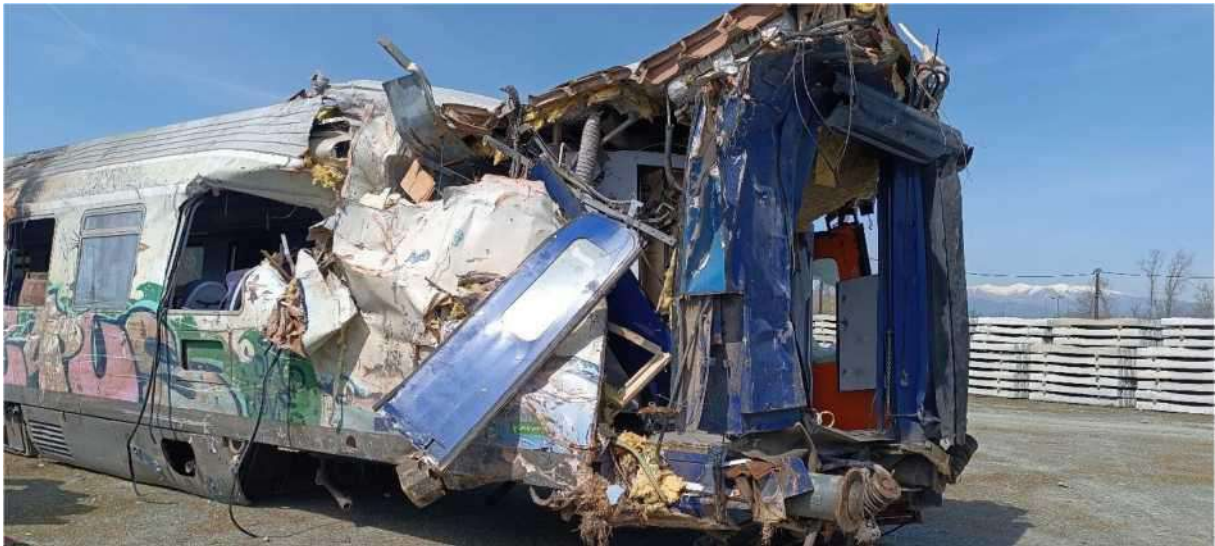
*Figure 88. Position 5) B3 2nd class coach, derailed and went down a slope, lost bogies, no other damage from derailment or crash, specific impact damage from B2 coming down from above.*

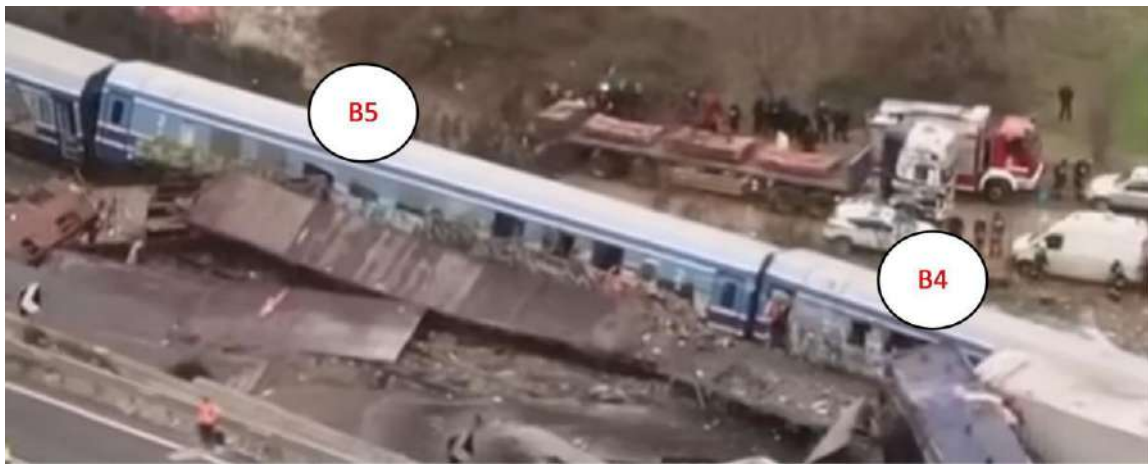
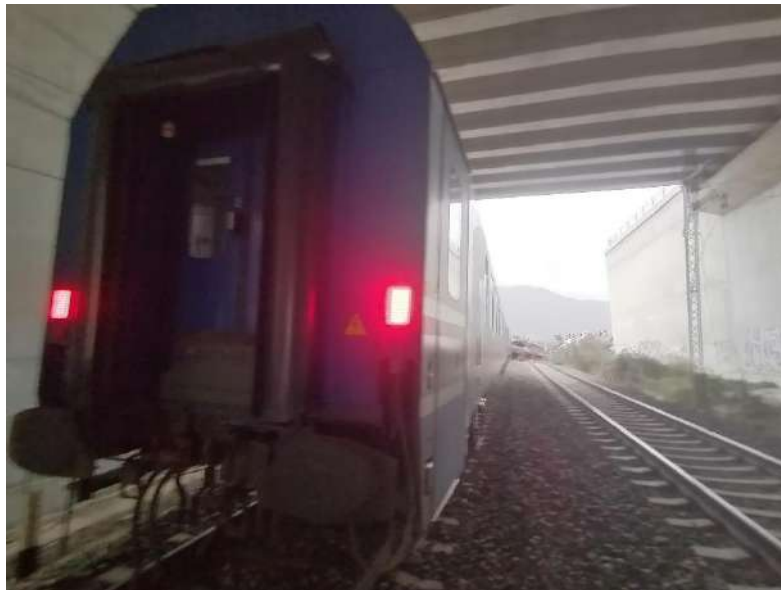
*Figure 89. Positions 6-9) B4-B7 coaches, B4 and B5 derailed and were hit on the side by steel plates, B6 and B7 did not derail, no damage, B7 remained nearly all in the tunnel.*
