Rail Accident Report

Head-on collision between a passenger train and a freight train  
in Tempi, 28 February 2023

RL01-2025, 27 February 2025

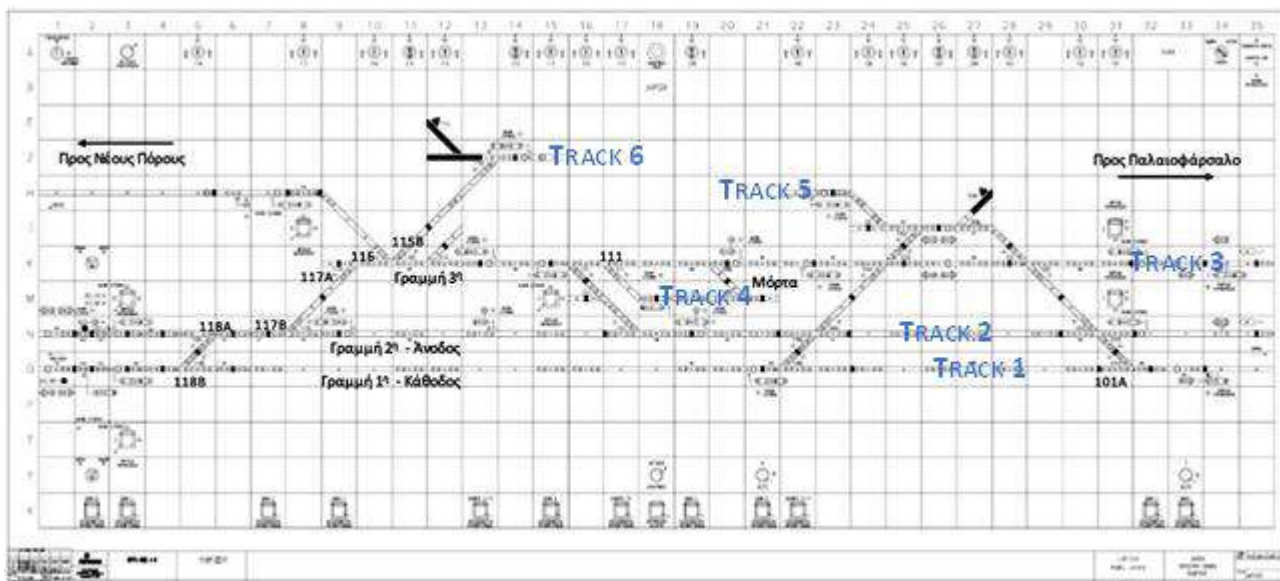
Figure 5. Scheme of the tracks at Larissa station as schematised on the control panel at Larissa Station

- 89 Within the Larissa station there is a signaling system which is controlled through a Control Panel placed in the station master's office. On the control panel the layout of the lines and switches are shown in a schematic form. It also depicts the indications of the light signals for the station, the position and locking status of the switches, the possible alignment of a route and the presence and position of the trains as soon as their first axle enters the track circuits.
- 90 The track type is UIC 60, continuously welded. The line is double track with standard gauge (1435 mm). The movement of trains is done via electrification (Airborne System with AC 25 KV). Communication between station masters is done via GSM-R and between station masters and train drivers via radio (VHF). No Train Protection System (ETCS or other) was operational.

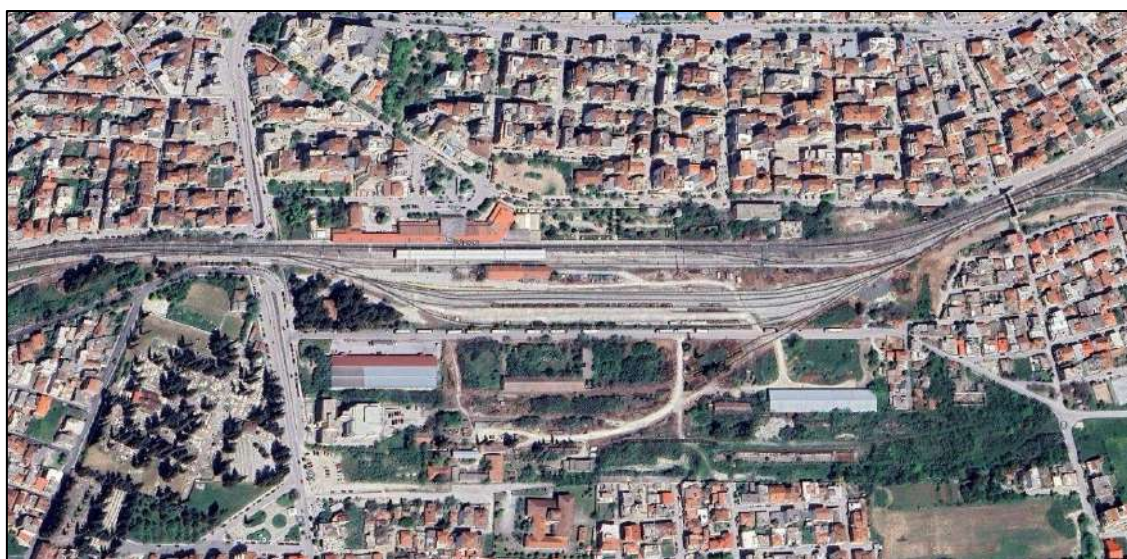
Figure 6. Railway map of Larissa Station (from Google Maps, 04/2023)

- 91 The signaling at the exit of Larissa station to Thessaloniki was not operational, because the renewal works (covered by contract 717) were only partly realised. As a result, the signal LAR11 to exit Larissa station towards the north was continuously showing a stop-aspect. Consequently, the station masters working in Larissa had to personally give the order to the train driver (written form 1001 or telegram<sup>3</sup> via VHF-Radio) to pass the red signaling in order to continue towards the next manned station Neoi Poroi.

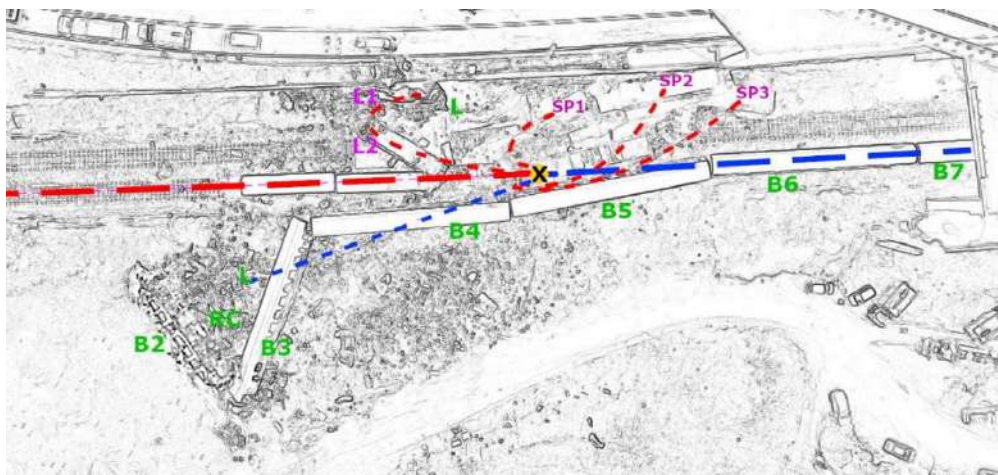
Figure 11. Global movement of the collision, with the initial impact and catapult effects.  
(SP1,2,3 are Steel Plates, and were also catapulted)

- 130 The 1st phase mainly involved the first 4 vehicles of the two trains: 2 locomotives 120-022 (first) and 120-012 (second) of the freight train and the locomotive 120-023 with its first-class A1 coach. The initial impact is a head-on collision between passenger train locomotive 120-023 and the first freight train locomotive 120-022, that causes the latter, along with the second locomotive 120-012 to be catapulted towards their left over the upward line track and smashed against the motorway wall, with the second locomotive making a U-turn and its rear end sliding over the steel plates carried on the 3rd platform of the freight train to come to a standstill with its front side against the first locomotive and its rear end resting against the first shipping container carried on top of the 4<sup>th</sup> platform of the freight train (Figure 10, Figure 11, Figure 12).

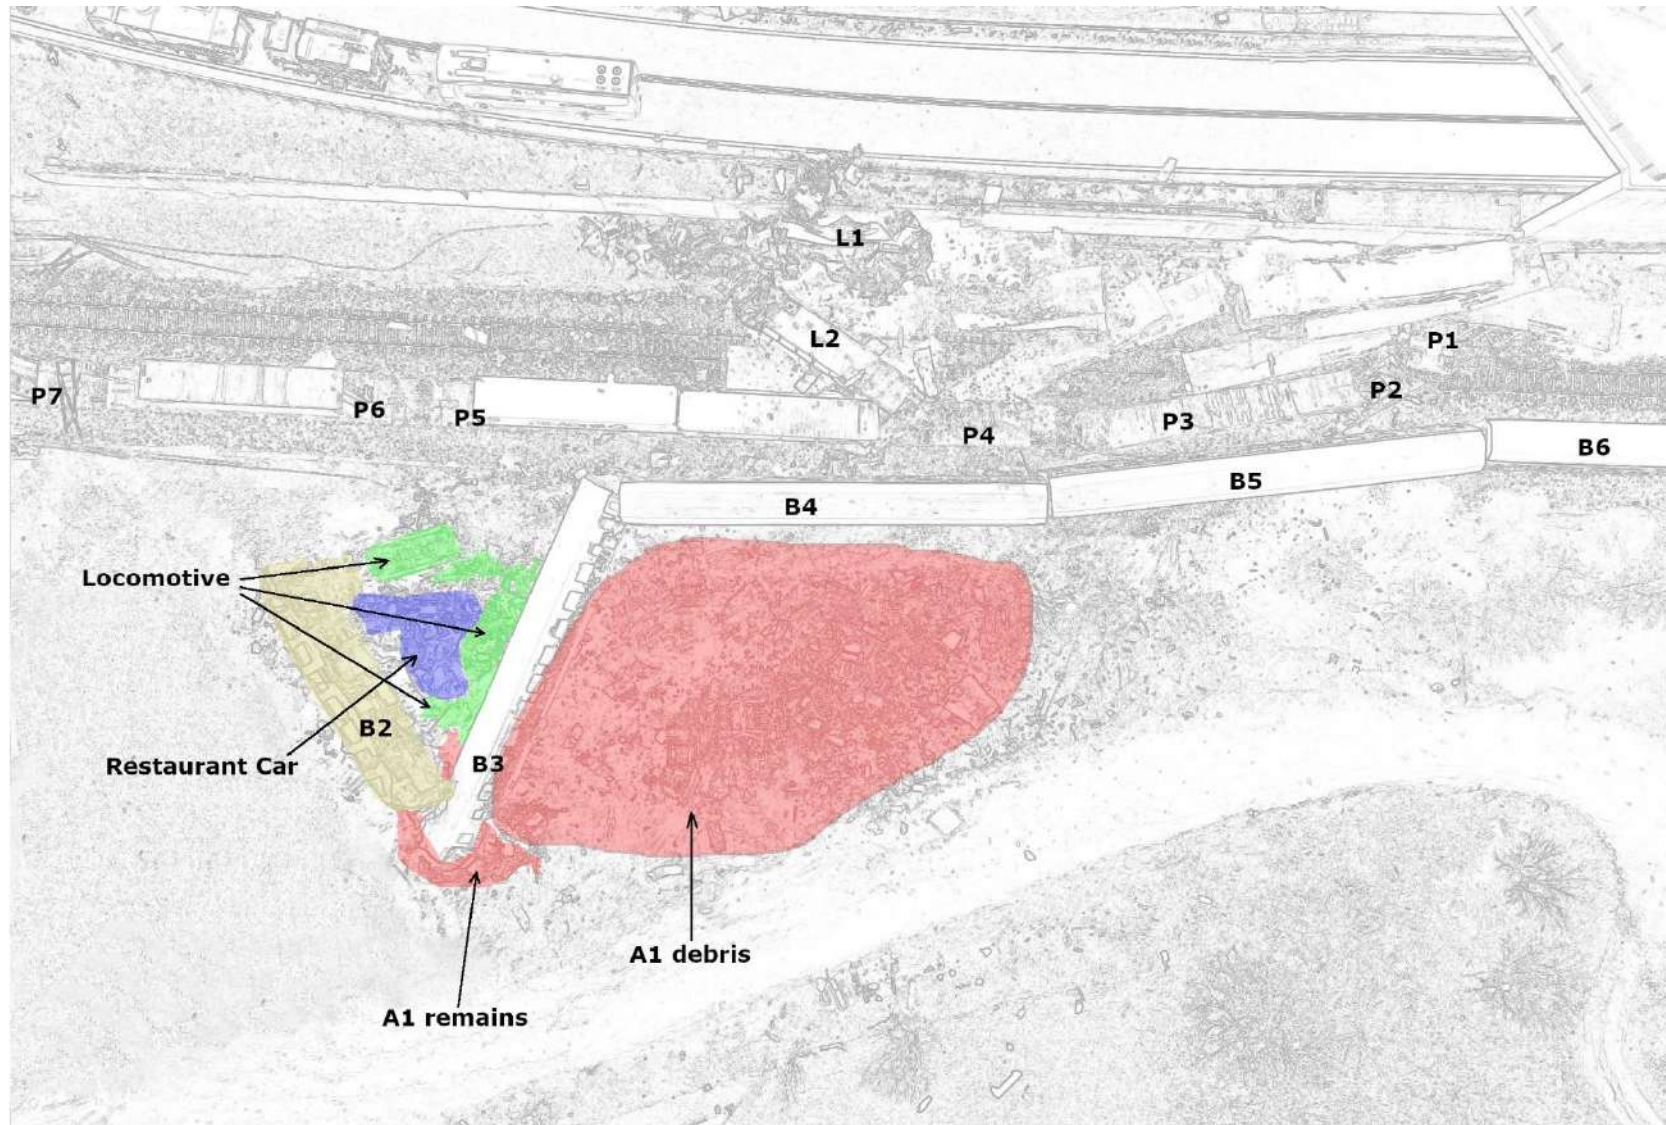
Figure 12. The accident site.

Best estimated point of the 1<sup>st</sup> collision: **X**, Freight locomotive 120-022: **L1**, and 120-012: **L2**, Passenger train locomotive 120-023: **Locomotive areas**, First-class A1 coach: **A1 areas**, **Restaurant Car** area, Second-class **B2** on B3 head, then **B3**, **B4**, **B5**, **B6**, (B7 under the tunnel), Freight train platforms **P 1-2-3-4**, and freight wagons 4-7 (and other 6 not on the figure).

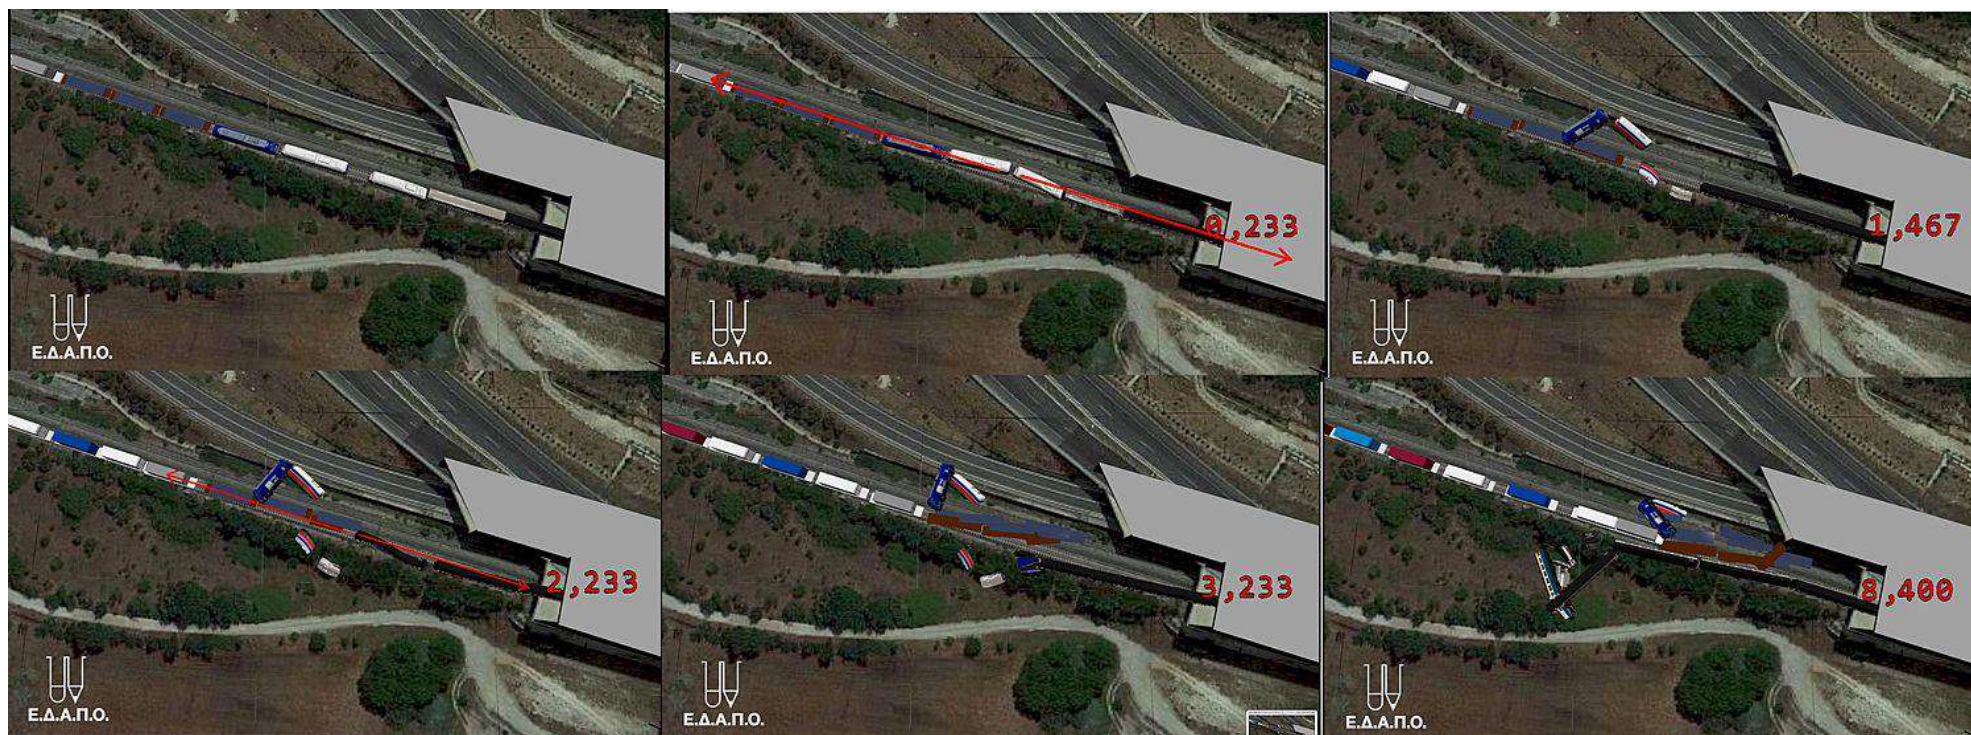
Figure 26. Overall view of the simulated accident mechanism with the timestamps: image 2 showing the 1<sup>st</sup> impact, image 4 the 2<sup>nd</sup> impact and images 5 and 6 the movement till standstill.

- 144 Finally, the fourth wagon of the freight train carrying a shipping container, hits the second freight locomotive 120-012 and then comes to a standstill. On the next page (Figure 26), a set of pictures extracted from an animated sequence proposes an overall view of the collisions with their timestamps: image 2 showing the 1st impact, image 4 the 2nd impact and images 5 and 6 the movement till standstill.

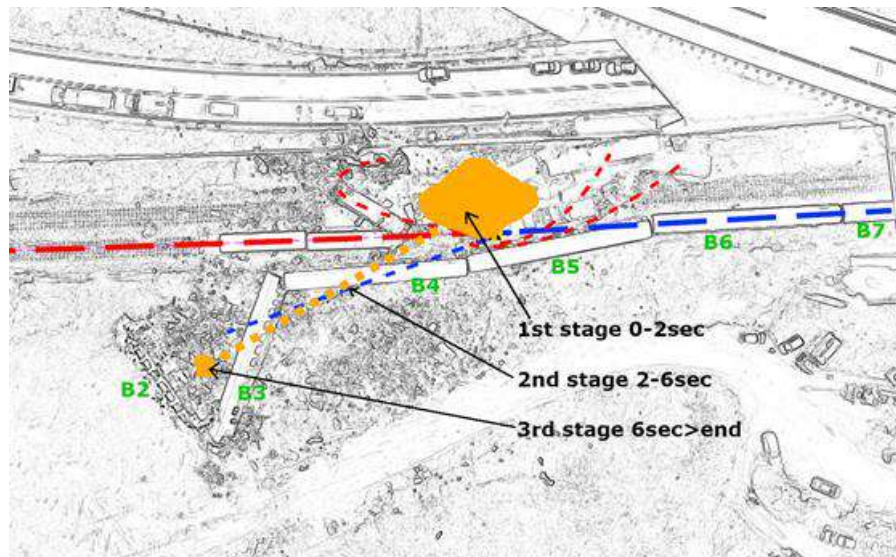
Figure 30. Clarification of the sequence with its timing.

- 150 Two separate pool fires continue to burn at ground level after the 1<sup>st</sup> and 2<sup>nd</sup> stage fireballs have extinguished themselves, indicating the start of a new, third stage.
- 151 Pool fire #1 can be seen burning brightly, near the locomotives of the freight train, for approximately 30 seconds. After that, it continues for an unknown period of time burning with smaller flames that can be seen from passenger videos but not large enough to be recorded by the remote cameras overlooking the scene. The video evidence shows stronger flames for 20 seconds and then a decrease in flame size that hides the fire from view, so it is not possible to accurately estimate the duration of this pool fire.

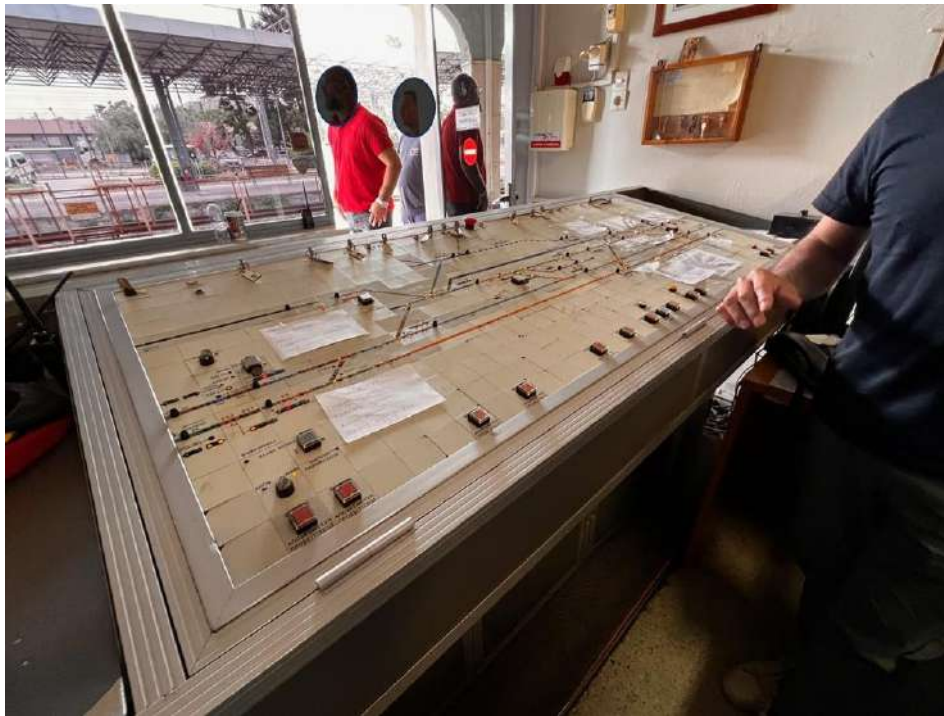
Figure 37. The control panel at Larissa Station

- 189 As it can be observed on the global photo of the control panel (Figure 37), it is a large area with many information and commands that cannot be considered at a glance. To pass from one mode to the other (manual mode to or from automated mode), the station masters must turn a numbered key (the number refers the number of the switch) on the top of the control panel (Figure 46), separately for each switch. The area where to read the switches numbers is small and partially hidden by the plastic and metal key rings (this point is further analysed in the chapter 4.2.2). In the actual practice of using these keys, as it has been explained and shown on site, at least two ways of manipulating them co-exist, one of them being indicative of lack of trust in the system and/or lack of experience (4.2.1.3).

- 243 The indications on the position of switched 118 are small indications, on two distinct positions, on a larger Control Panel (the information of the Figure 47 among the ones from the whole Figure 37).

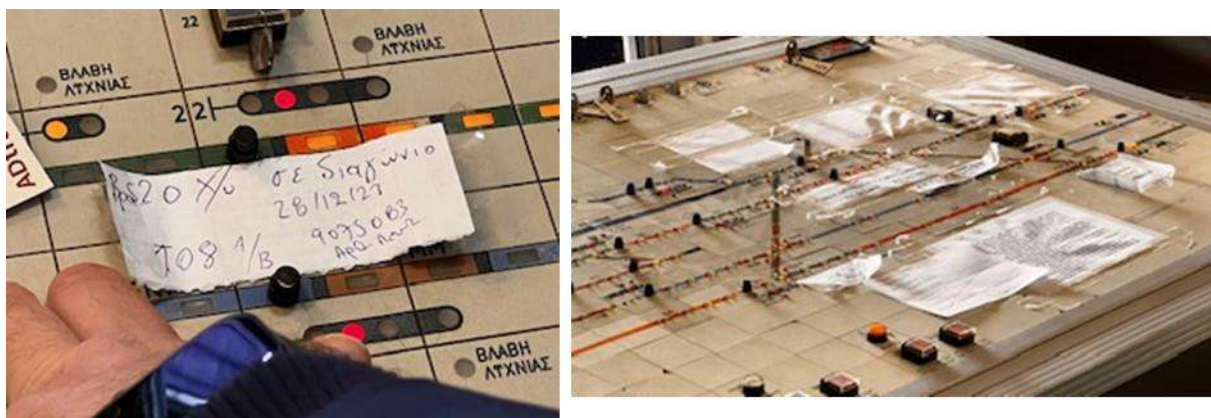
Figure 40. Useful pieces of information.

191 The Larissa control panel in the station masters' traffic control room, as well as others in actual operation (Figure 40), is supplemented by pieces of paper “taped” or just “laid” on the inclined panel. Their operational function is to remind the station masters of important local information on operational restrictions or degradations, some for a few hours, others for months (and even longer).

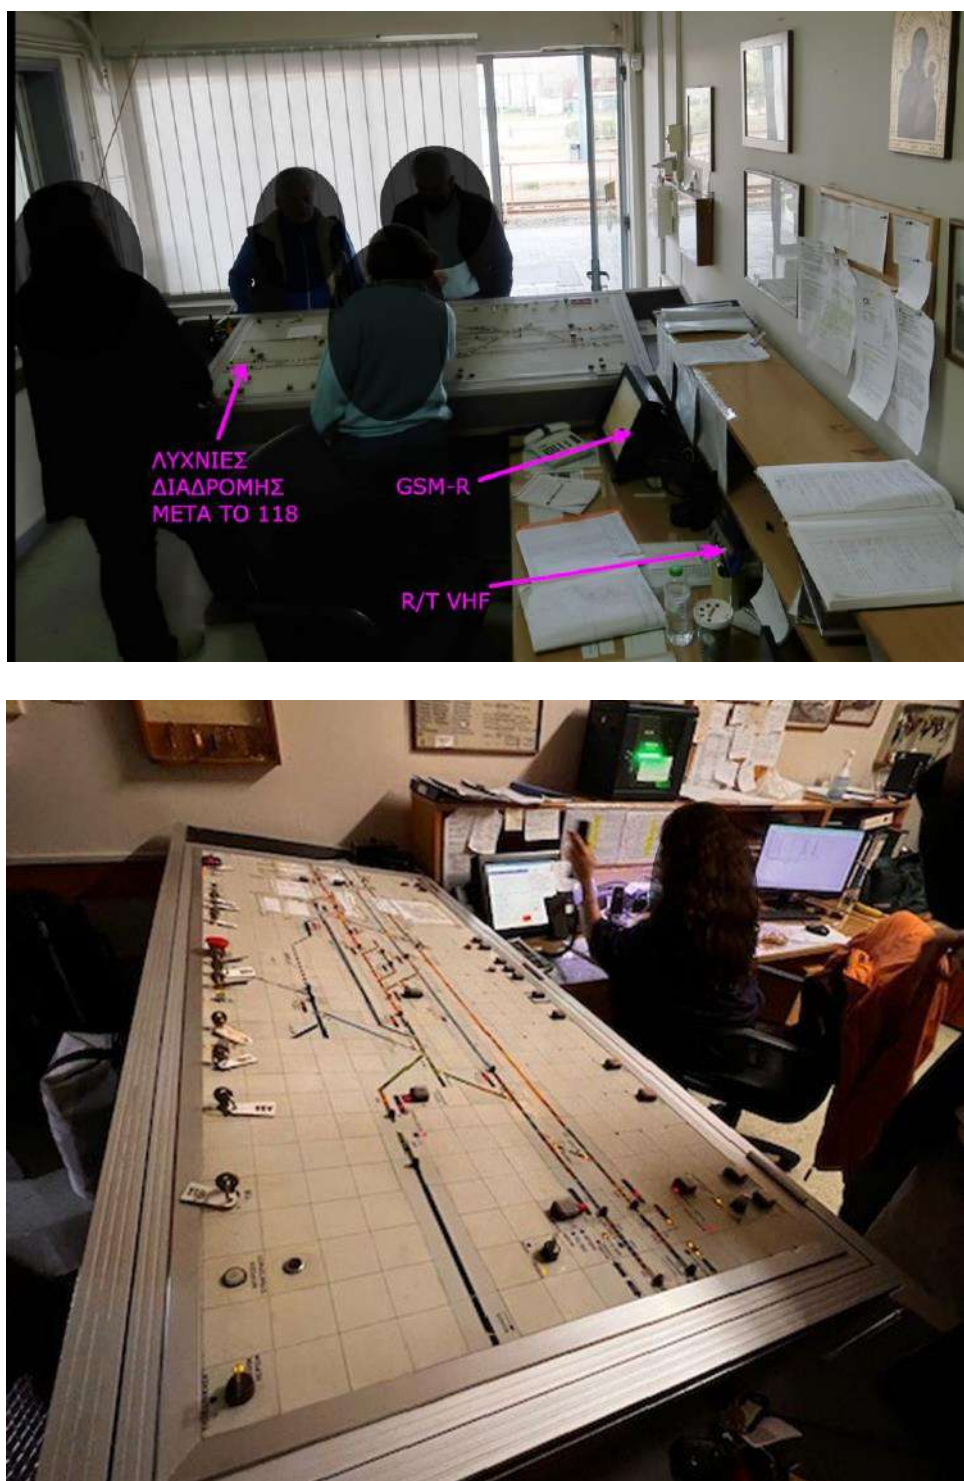
Figure 41. Positions of station masters when facing the control panel (above) and when communicating (below) in Larissa station.

192 Taken together with another source of influence, namely the numerous communications (as analysed in point 4.2.1.8), in the period of time just before and while the control panel was showing the passage of train IC-62 (240), it should be noted that this panel and the communications area are organised and physically positioned in a way that makes it very difficult to perform both tasks at the same moment. In morning and afternoon shifts these tasks are performed by two station masters in order to avoid excessive workload. When you are concentrating on communications, you are turned sideways in relation to the control panel and the LEDs that are lit in this case are behind you (Figure 41. Positions of station masters when facing the control panel (above) and when

- 193 ). This directly, logically and naturally explains how Larissa's station master did not 'see' or 'look', and therefore did not 'detect' the train's passage towards the descending track (4.2.2). During the investigation, 2 other situations were identified by the investigation team: one in which the station masters had adapted it and added a desk just in front of the control panel (Figure 42), and the other one, in Athens, when a Station Manager reported this as an issue and their manager made the situation more adapted.

- 245 Furthermore, the way the communication means (VHF console, GSM-R and telephone) are positioned on the right of the control panel and at a lower level (Figure 41). This means that, when occupied with whatever communication and logically directed towards the used means of communication, the indications related to the position of switches 118 and the departure of train IC-62 were situated behind the left shoulder of the station master in the left bottom corner of the control panel and so in practice invisible (192).

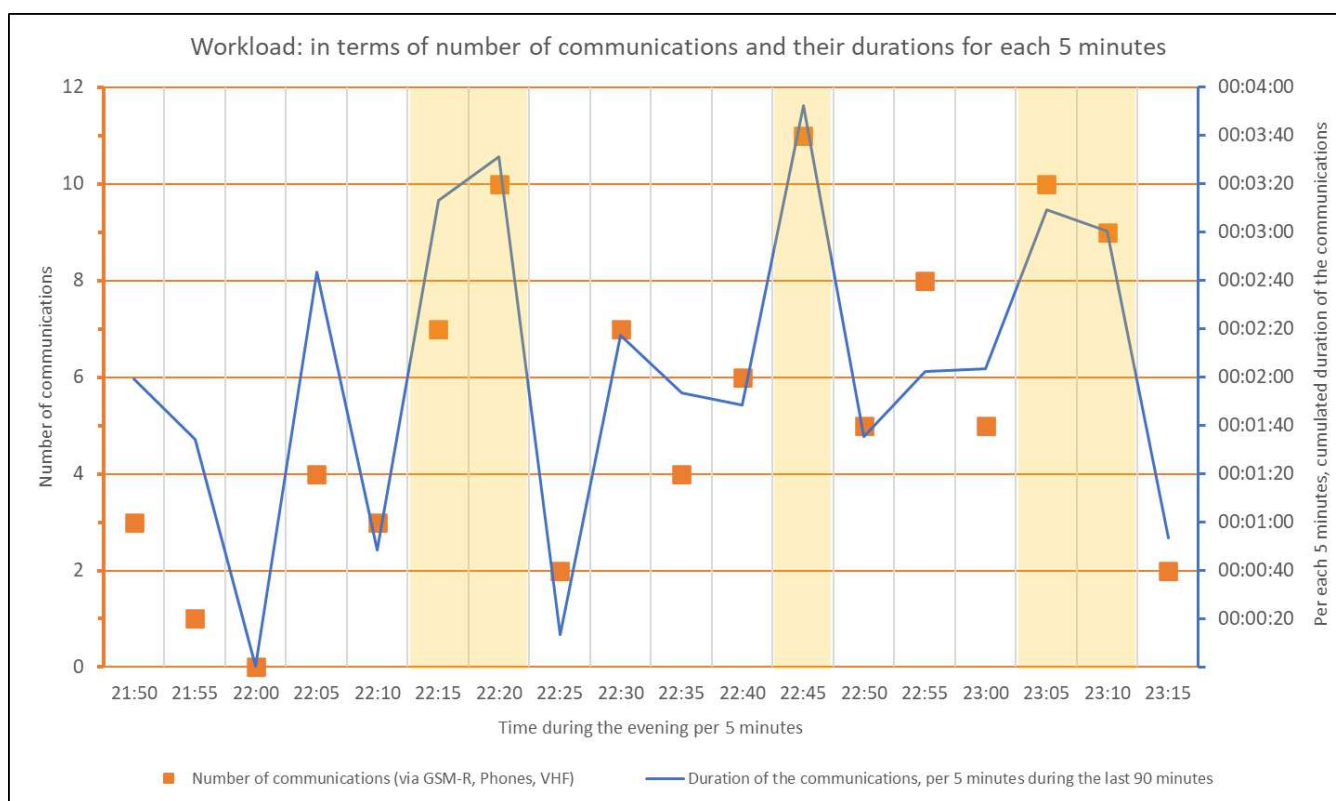
Figure 44. Factual analysis of the communication workload as a risk to be taken into account during HOF integration.

- 219 The variability that resides in the error made by the Larissa station master may have parts of its sources of influence in the amount, the duration and the diversity of the communications he had to treat, process or follow-up, especially during the last hour and even more during the last half an hour. Indeed, considering the number of interlocutors (train drivers, switch operator, level crossing guard and residents, policeman, station staff, traffic regulator and other station masters), the topics, and the duration left to “think” or “write”, several experimented station masters including one of their managers admitted that the workload at this period of time was more than critical. And with such a combination of workload factors being very rare, it can be considered that this situation has been a huge trap for an insufficiently prepared or unexperienced station master.

- 220 Analysis of only the communications, not even taking into account other tasks, indicate three peak periods (Figure 44) that appear to correspond with the consecutive mistakes made by the station master: setting the routes for respectively the train 2597 and IC-62 and not detecting the mistake with switch 118. This indicates that periods of too heavy workload, in particular for less experiences operators, can be a direct cause for errors, mistakes and routine violation, because there is “no-time-to-think” or one is “captured-by-the-flow-of-issues-to-contain”. This type of workload analysis, with results beyond human capabilities, shows the importance of integration human and organisational factors in risk management practices (4.2.80).

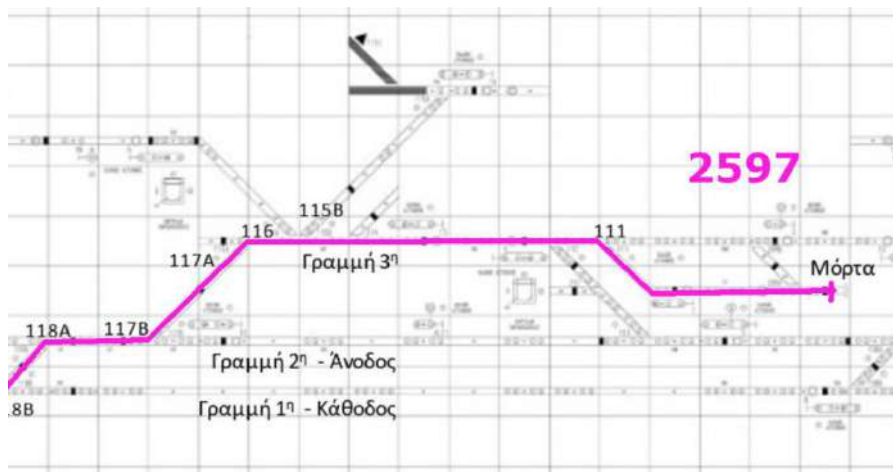
Figure 45. The route for the entry of train 2597.

#### 4.2.1.9. Dynamic additional workload

When manually setting the route for the entry of train 2597, the station master of Larissa forgot to turn the switches 116 and 115B in the correct position. On other occasions these switches would have been in the right position after the entry and acceptance of train 2575 from Volos on track 3. Earlier in the evening, on the 28/02 this train 2575 was positioned on track 6 at 22:10 by the station master of the afternoon shift because track 3 was occupied with train 2594 that had been brought back to the station at 21:30 after traction problems arose on its way to Neoi Poroi (93).

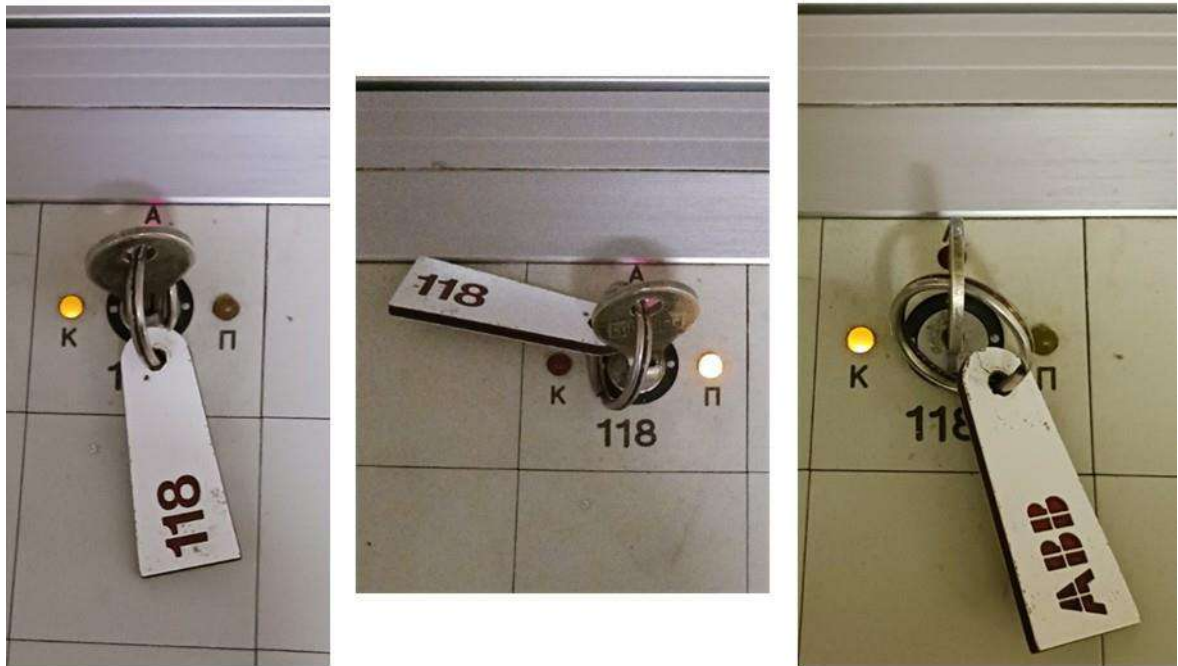
Figure 46. Detail of the three-position key for handling switches 118 on the Larissa Control Panel.

- 236 On the upper part of the control panel, there are three-position keys that are numbered according to the electrically driven switch they handle. These keys are used for the independent, manual control of any electrically driven switch. Turning the key from the central position by 90 degrees counterclockwise will command the switches to move to the "main" position (indication "K"). Similarly, by turning the key 90 degrees with the clock, the switches are commanded to move to the "bypass" (indicator "Π") position. When there is a correspondence between the physical position of the switches and their control key, the yellow light diode for the indicated position of the switches is lit steadily. Above the key of each switch, there is also a red light diode, in the central position marked "A". This is the position the key should be put in to allow for "automatically setting" the routes. (Figure 46).

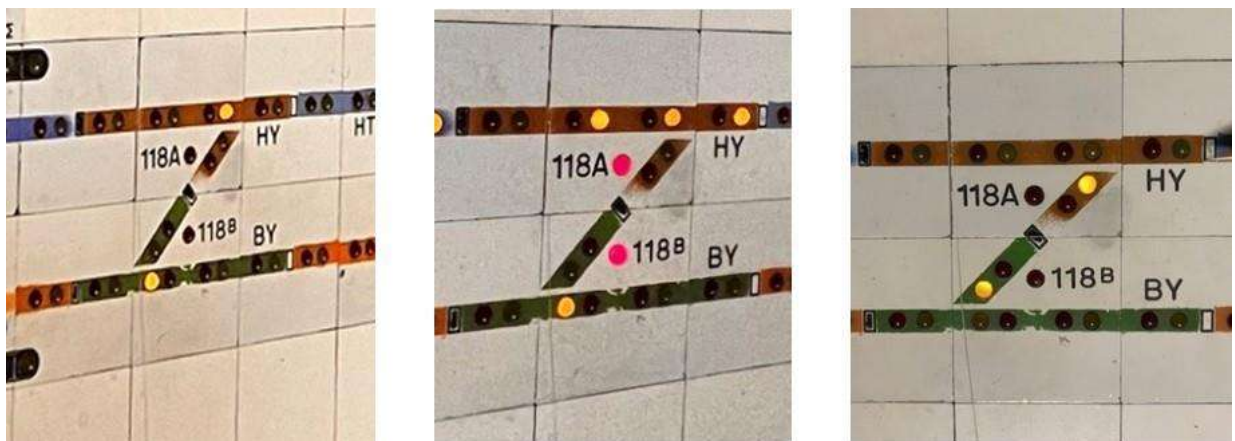
Figure 47. Detail of the switches 118 on the Larissa Control Panel (main-moving-bypass).

- 237 Switches are indicated on the Control Panel by the intersection of the lines showing the railway lines. Each switch is marked with a number and a letter if two switches have the same number. There are two yellow lights that indicate the position of the switch position in "main" or "bypass"(Figure 47). By setting the route, the lights in the area of the switches light up, as a combination of the light at the entrance of the switch and either the "main" or "bypass" path.

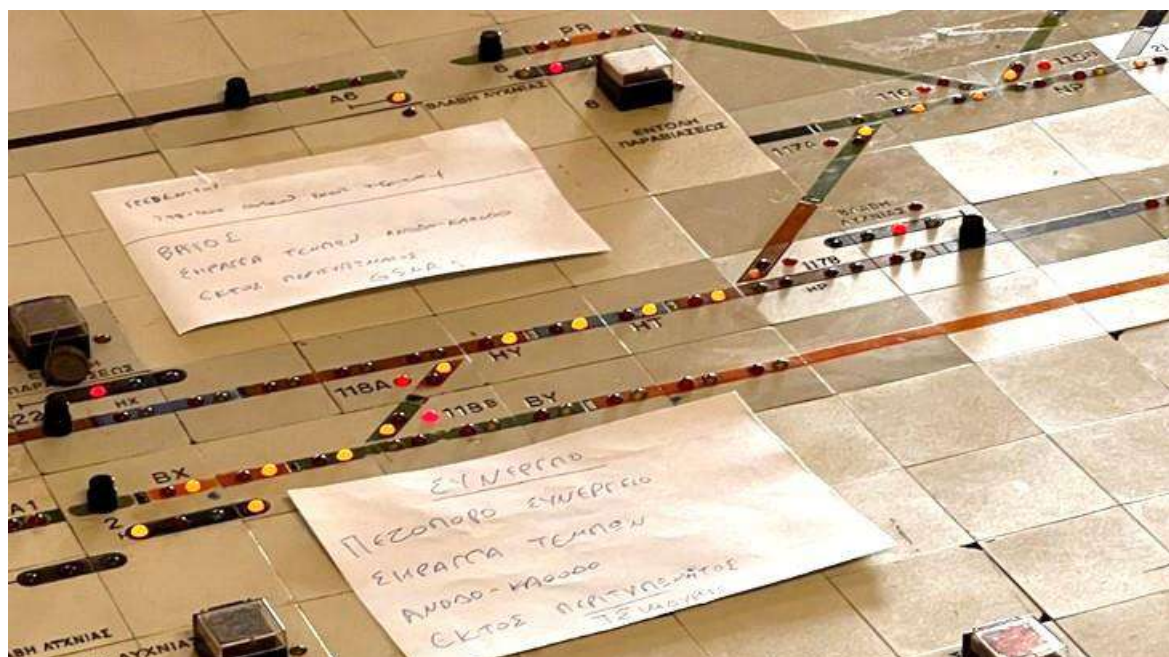
Figure 48. Detail of the Larissa Control Panel with a route set to cross a switch in a bypass position.

Lines on which the presence of a train is detected by track circuits or axle counters are displayed on the Control Panel in a sequence of colours delimiting the track circuit or the area controlled by each axle counter. The main lines use a sequence of colours orange/green for the ascending and blue/brown for the descending tracks (Figure 48). Within the coloured lines representing detection circuits photodiodes are placed that light up to give information to the panel operator. Lighting the yellow light on a track circuit means that a train has been "routed" to cross the section of line which is bright. The yellow light remain bright until the train reaches the circuit, when they are switched off and replaced by a group of red lights, which means that there is a train in the specific detection circuit.

In the section EA3 (indicated as “EA” on the control panel) there was a permanent indication of occupation as the signalling towards the north of Larissa had not yet been completed. This means that one of the lights in that part of the control panel showing a red aspect, would not be perceived as exceptional or worrying and would probably not immediately attract the attention of the station master.

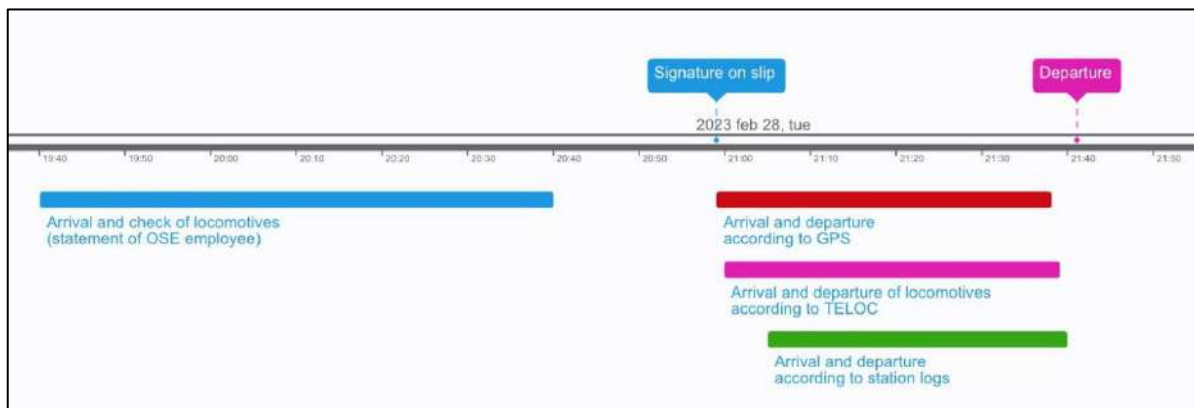
Figure 51. Timeline of the movement of the freight train 63503

- 284 The same timeline of events is supported by GPS data of the movement of the locomotives as provided by Hellenic Train. A similar timeline is supported also by the logbook of the station master at Thessaloniki Freight Station (locomotives arrive at 21:05, test finished by 21:35 and train leaving at 21:40).

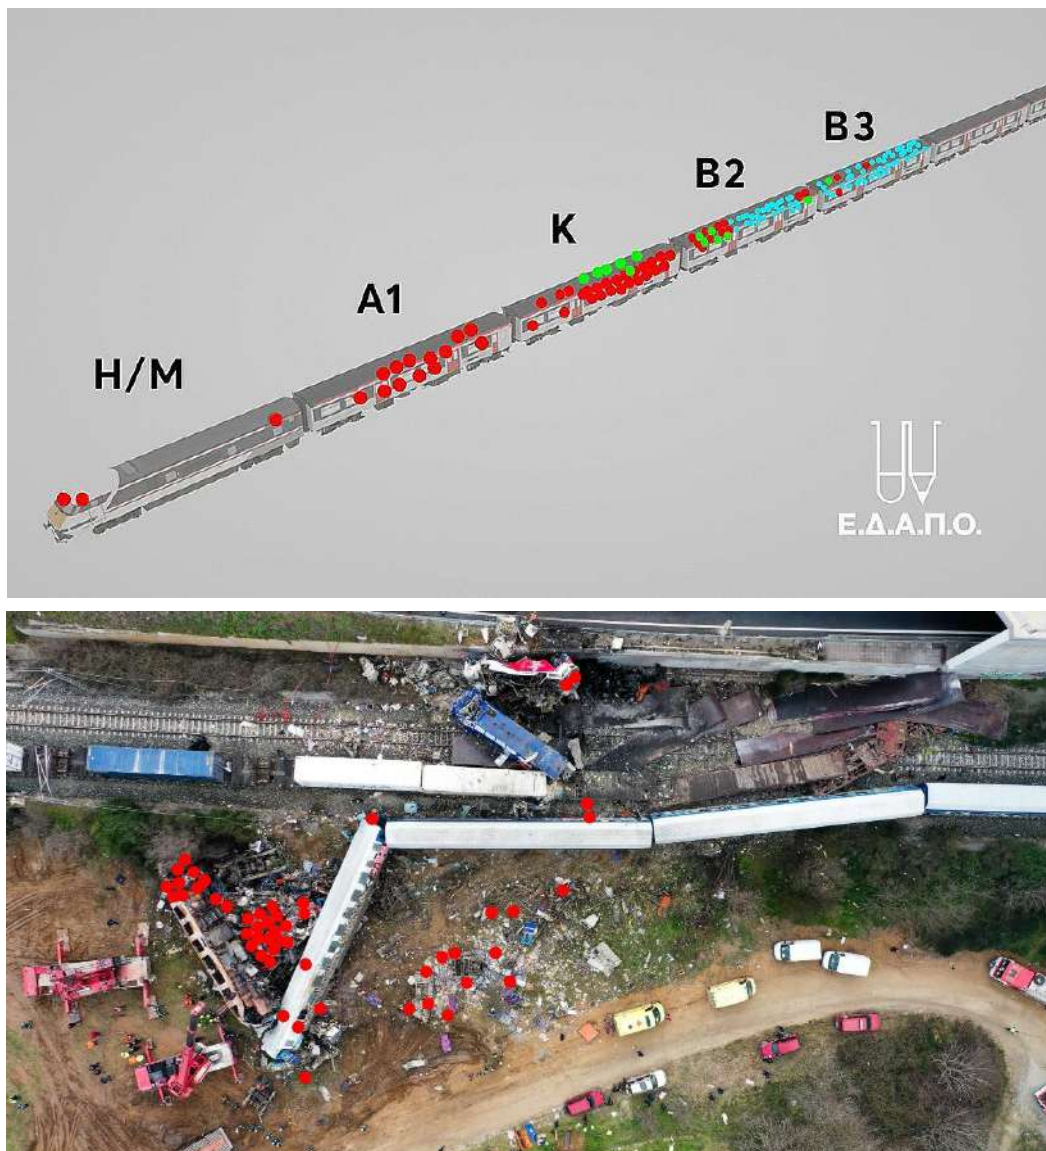
Figure 55. Initial and final estimated positions of fatalities, visualised on the scheme of the impacted part of the IC-62, and on-site.

- 423 The B3 coach of the passenger train was not subjected to heavy deceleration forces and was totally survivable, if not for secondary impacts from the B2 coach hitting its roof and a section of the locomotive hitting against the side of the B3 coach. There were 2 casualties that both suffered severe head and spinal trauma due to impact by heavy debris entering through the side windows. Both casualties were killed instantly without any chance of survival, given the unlucky position they happened to be at (other passengers sitting next to them were practically unharmed). And 5 injured victims were ejected during the crash or jumped from a height to exit the carriage.

- 445 Of the total length of the passenger train IC-62, the only parts that were totally consumed by the fire were the rear part of the Restaurant Car (letter K on the drawing, Figure 55, page 91) and the B2 passenger coach.

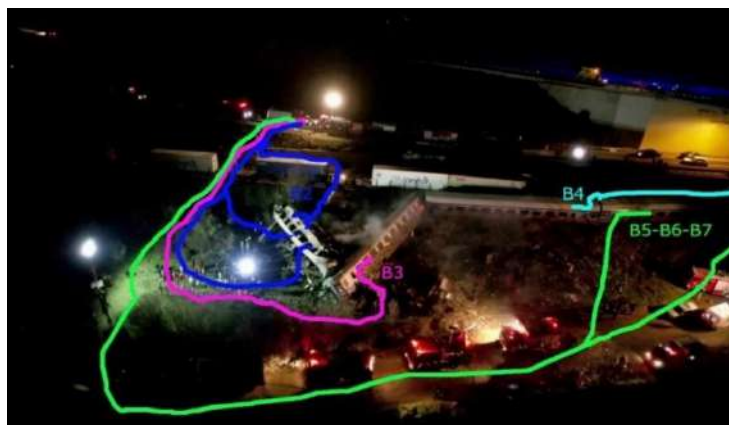
Figure 56. Self-evacuation paths of passengers before emergency services arrived at the scene.

- 427 Passengers from coaches B4 to B7 managed to operate the emergency handles of the doors and open the doors to self-evacuate successfully. On the B3 coach, access to the front doors was limited due to parts of the roof collapsing and blocking the narrow passage to the door. Passengers chose to break a window on the left side and climb down from there in order to self-evacuate. The Fire Service used the same window in order to enter and evacuate 3 casualties and 3 injured passengers who were trapped and needed mechanical tools to release them.

- 428 At least two passengers sustained serious injuries (bone fractures and dislocations) during evacuation: 1 female passenger jumped from the top row of windows of the B2 coach and was injured by falling on debris below (subsequent passengers jumping from the same window avoided this by throwing their luggage to land on top of softer surface) and 1 male passenger who was the first to jump from the B3 coach front left window, sustained serious injuries by falling on debris below (subsequent passengers evacuating from the same window took care to climb down carefully in order to avoid injury). An unknown number of passengers were reportedly lightly injured during evacuation, mostly in a similar way.

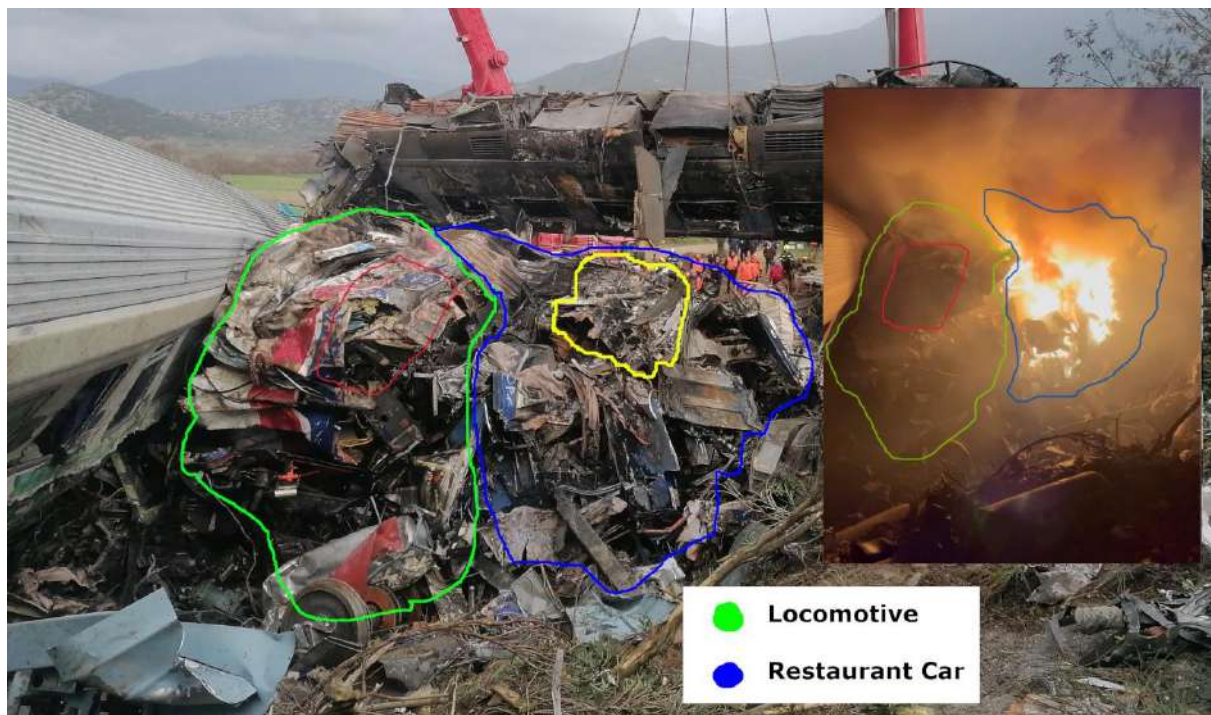
Figure 60. Restaurant burning next to the passenger train locomotive, with the position of the transformer in red.

- 462 The passenger videos show a very strong but very concentrated fire burning fiercely from the bottom of the Restaurant Car (color yellow added) while the remains of the passenger train locomotive (including the transformer filled with silicone oil) can be observed at a very close distance but clearly not on fire. This observation can be verified by the examination of the remains of the trains on the next day (Figure 60, Figure 61), where it is clear that the locomotive (color green added) is mechanically destroyed and, like the transformer (color red added), only has burn marks on one side, while the Restaurant Car (color blue added) is totally consumed by the fire.

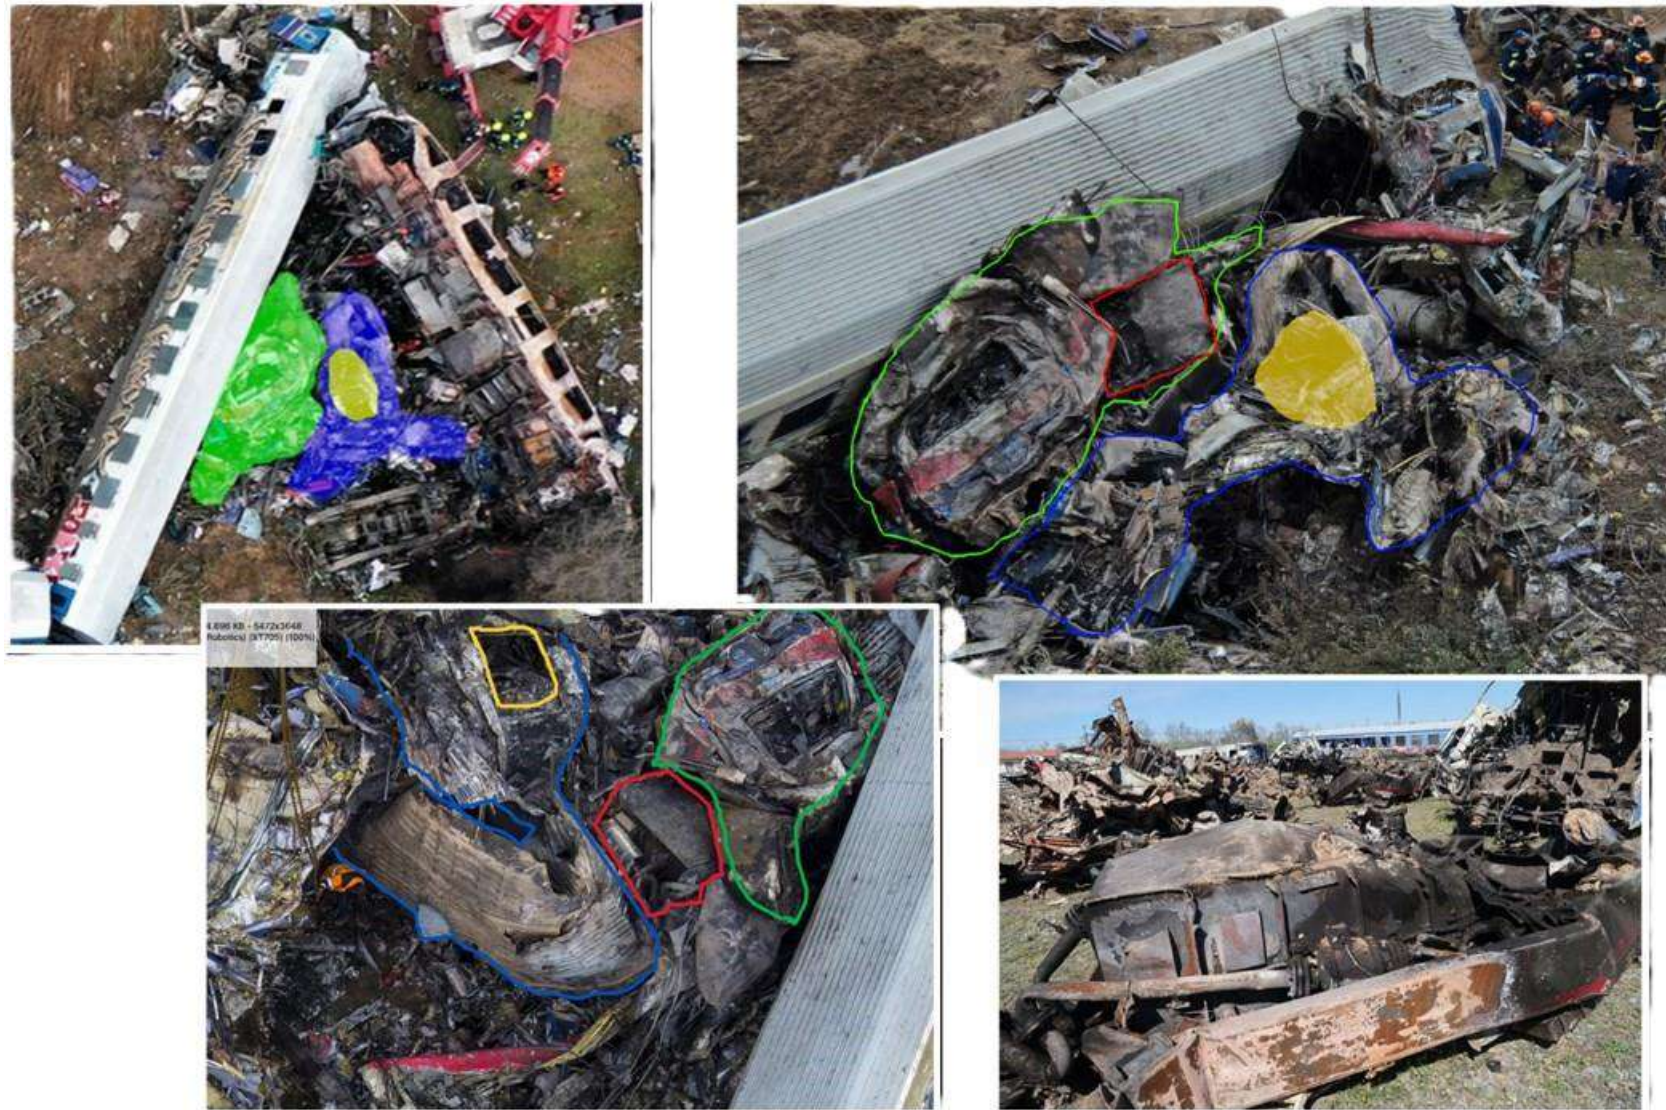
Figure 61. Further images of the location of the Restaurant Car, Passenger Locomotive and its transformer.

- 463 By following this fire backwards in time, it is most likely that the fire that consumed the Restaurant Car is the same fire that has been recorded 4 minutes after the crash, burning from the bottom of the (crashed and bent in an S-shape) Restaurant Car (color yellow added). This is also the same fire that is observed from the "Maliakos-Kleidi" camera (Fig. Y), as an uninterrupted continuous movement from the fire plume (stage 2) to pool fire #2 (stage 3).

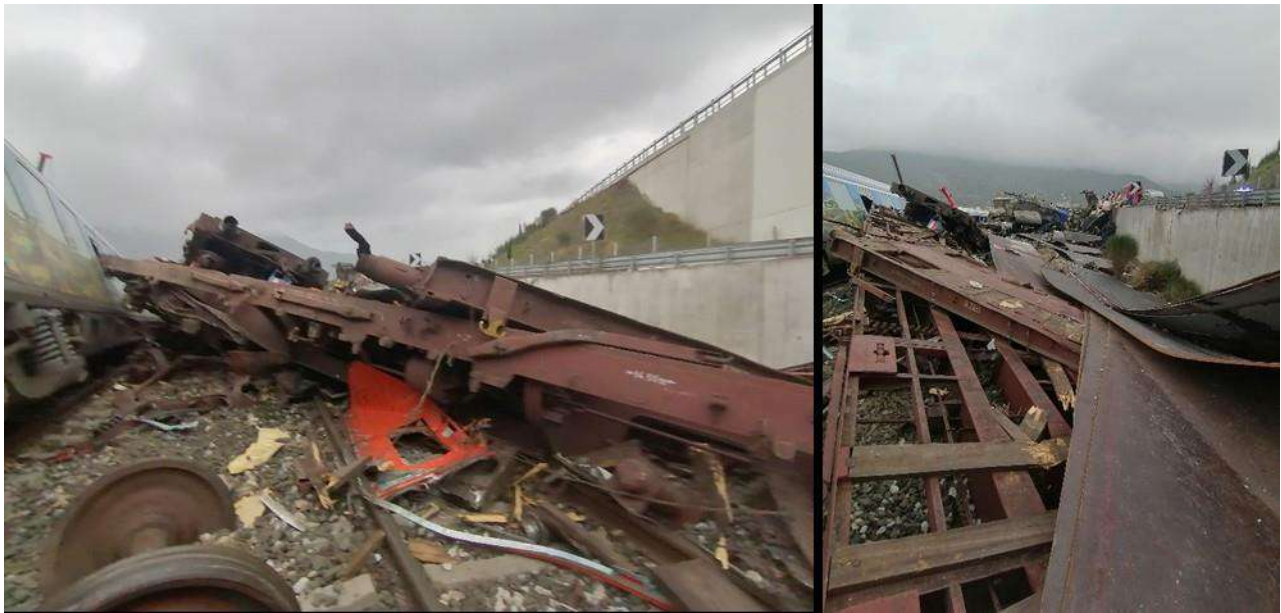
Figure 82. Platforms as found on the accident site.
