Rail Accident Report

Head-on collision between a passenger train and a freight train  
in Tempi, 28 February 2023

RL01-2025, 27 February 2025

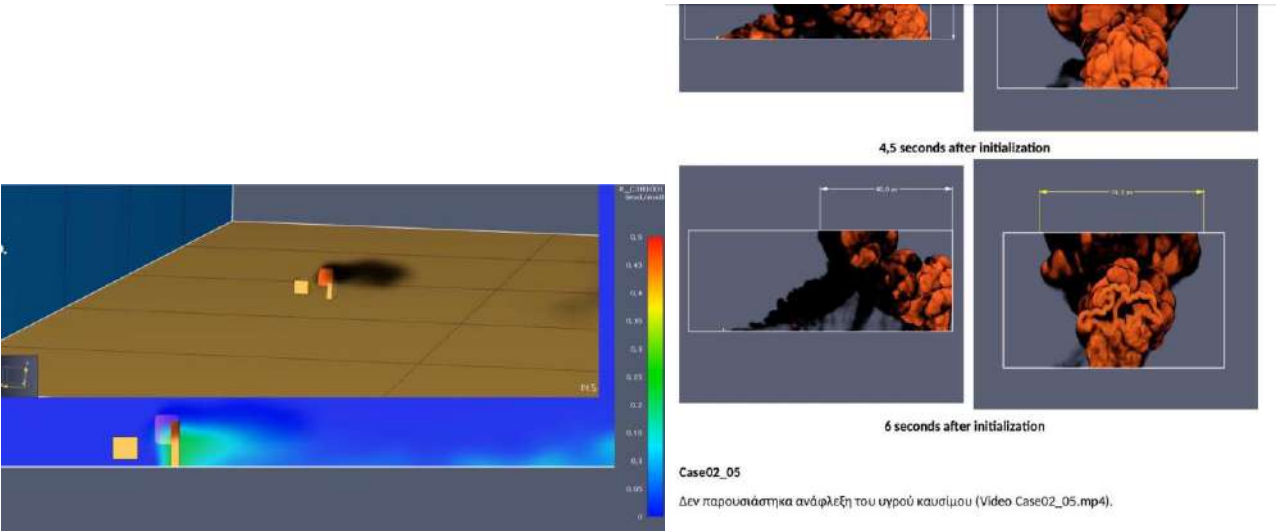
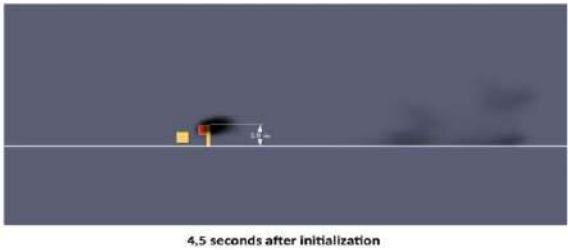
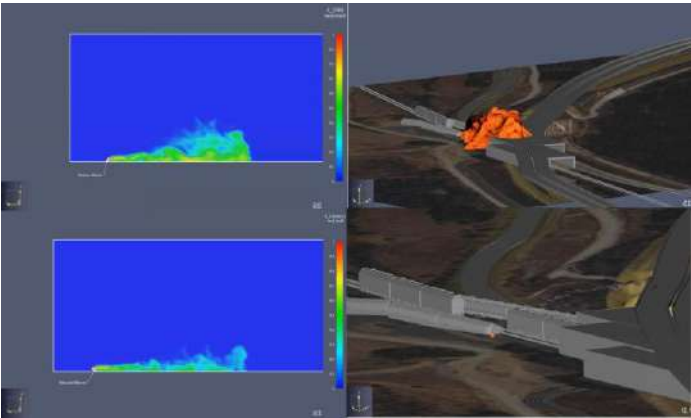
Various tests were run in order to simulate the possibility of silicone oil actually igniting in the presence of a heat source, in the form of an open flame (a pool fire inside a large bucket) or a heated vertical plate. Silicone oil was considered already atomized in small droplets of 500nm (much smaller than the 1000-4000nm as estimated by the RI.SE. report) and the total quantity of fuel was blown in particle form against a heated wall or an open flame. Several simulations were run using different geometries of release and dispersion and different values of AIT (auto-ignition temperature), starting from the realistic value of 450C and going down to 350C as suggested by UGent in order to simulate the possibility of piloted ignition, and even down to 250C which is an unrealistically low value that would be representative of less safe mineral oils.

The results of these tests rule out the possibility of PDMS silicone oils creating such a big fireball and pool fire, as the only possible result is a small localized ignition that will not propagate through the rest of the material, even if the total quantity of silicone oil is unrealistically atomized and dispersed all over the area.

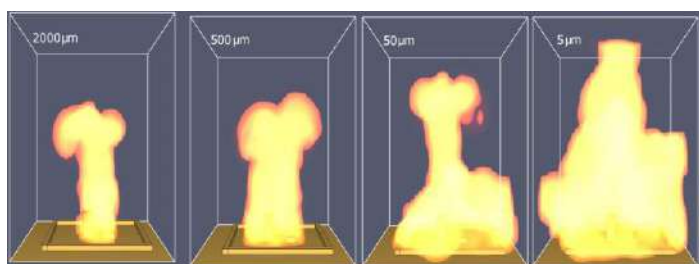
Droplet size (particle diameter) was evaluated and a comparison was run between particle diameter of 5, 50, 500, 2000μm in a particle release of similar characteristics to the one used in the final model. It was observed that there was a considerable difference when droplet size was very small (5 and 50nm) in comparison with the chosen value of 500nm, but for the larger diameter of 2000nm the effect was much smaller, indicating that in order to study an event with millimeter-sized droplets, 500nm particle diameter is deemed reasonable.

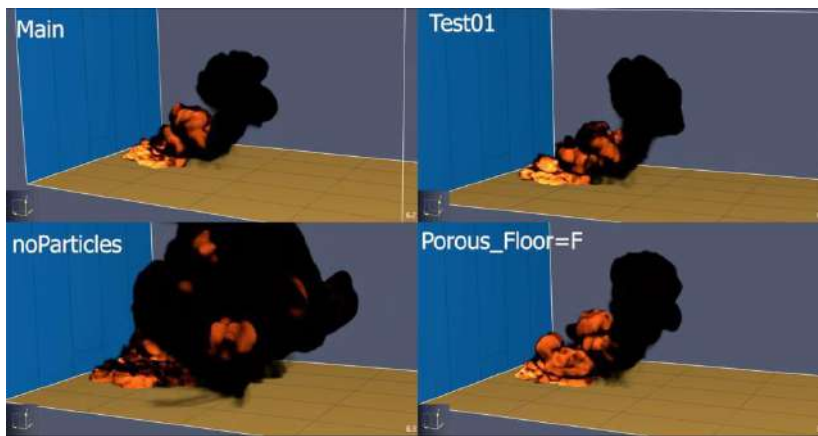
Also, a comparison was run between different amounts of liquid, gas and combined liquid and gas state of the same fuel, in order to validate the sensitivity of the FDS software to changes of state of fuel. Due to lack of any information relevant to volumes of fuel and their headspace, it was decided that no assumption would be made on this issue and the total amount of fuel would be considered as liquid particles.

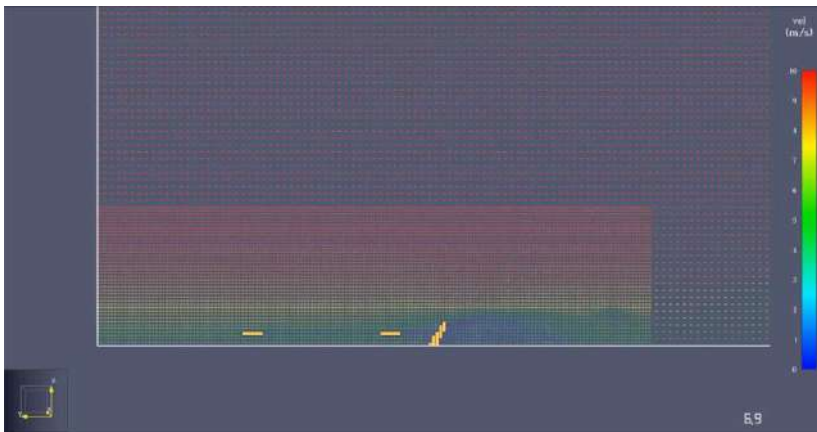
Boundary conditions were also compared in various small scale tests that gave an indication of the effects of the wind profile to the shape of the fireball. It was understood that small changes in the wind profile could affect the shape but not the maximum diameter, the rate of development of the phenomenon or the total duration of the fireball, so a realistic wind profile as close as the meteorological conditions of that day was used with the understanding of the small effect in the end result.

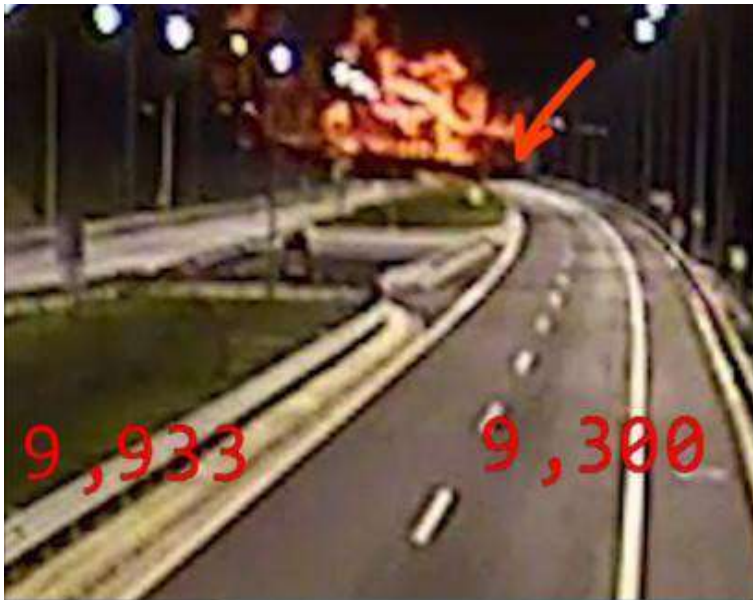
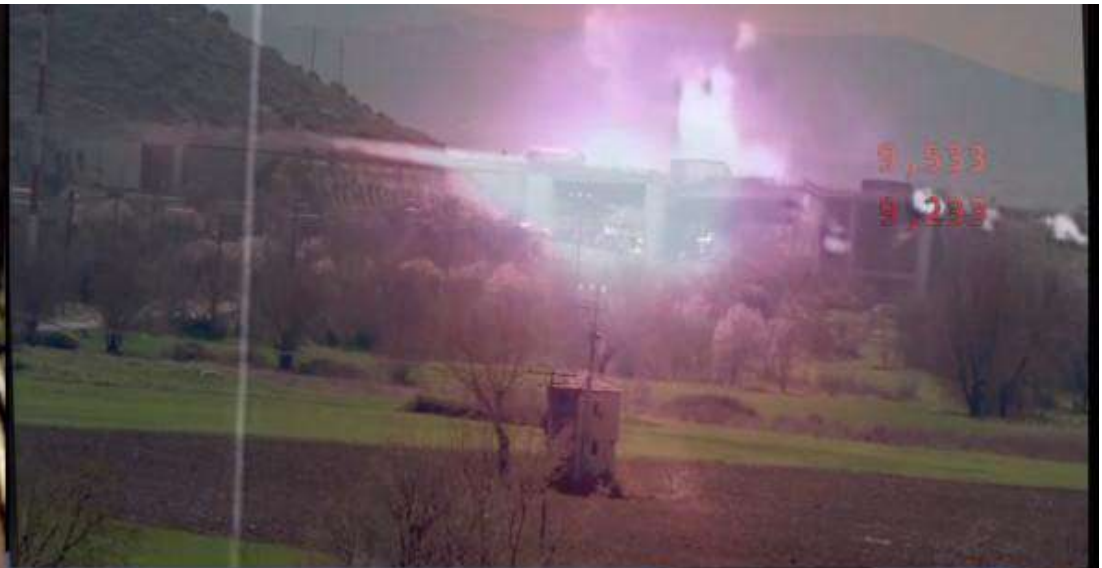
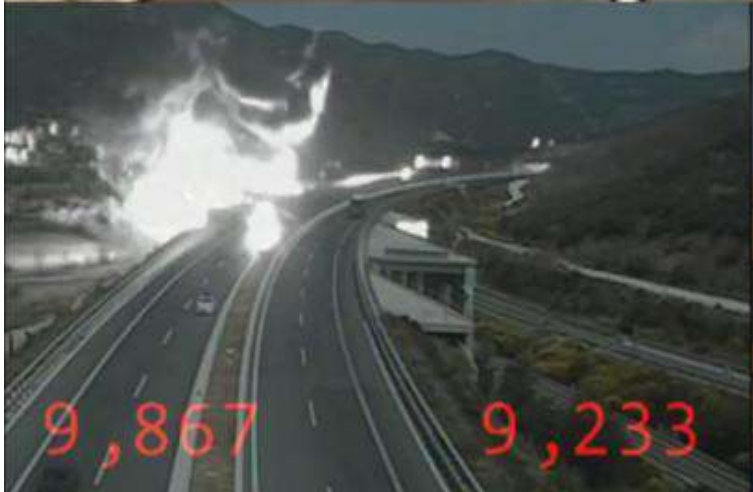
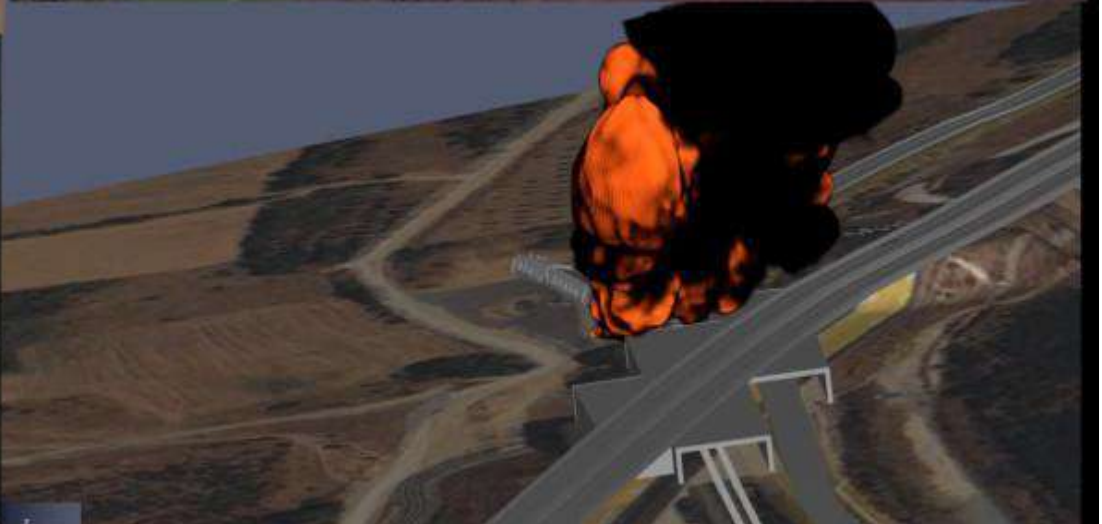
As for the Stage 1 initial release, a comparison of different possible geometries and initial speeds of fuel release showed that the most realistic results were obtained when the fuel particles were blown towards an obstruction with an inclination that would deflect part of the fuel spray upwards and another part to the side. After testing 12 different combinations of fuel quantities and fuel speeds for the two releases, the one most closely resembling the recorded video was Case08\_07 with respective quantities of 800 kg for stage 1, 1200 kg for Stage 2 and 300-500kg for stage 3 pool fire. Obviously, this is only to provide an order of magnitude and not an exact number, as there are other combinations of fuel, velocities and geometries that could possibly replicate the target video. It is clear, though, that the order of magnitude is correct, as it is not possible to create a comparable sized fireball without at least 2000kg of fuel. Furthermore, absence of a large pool fire #1 as recorded by video evidence, rules out the possibility of a larger quantity of fuel (e.g. 10-15tn) that would have created and sustained a large pool fire as an aftermath to the crash.
